STABILITY OF EXCAVATIONS AND DESIGN OF MINING

LAYOUTS IN A DEEP LEVEL POTASH MINE

A THESIS

H.D.S. MILLER B.Sc., (Wales)

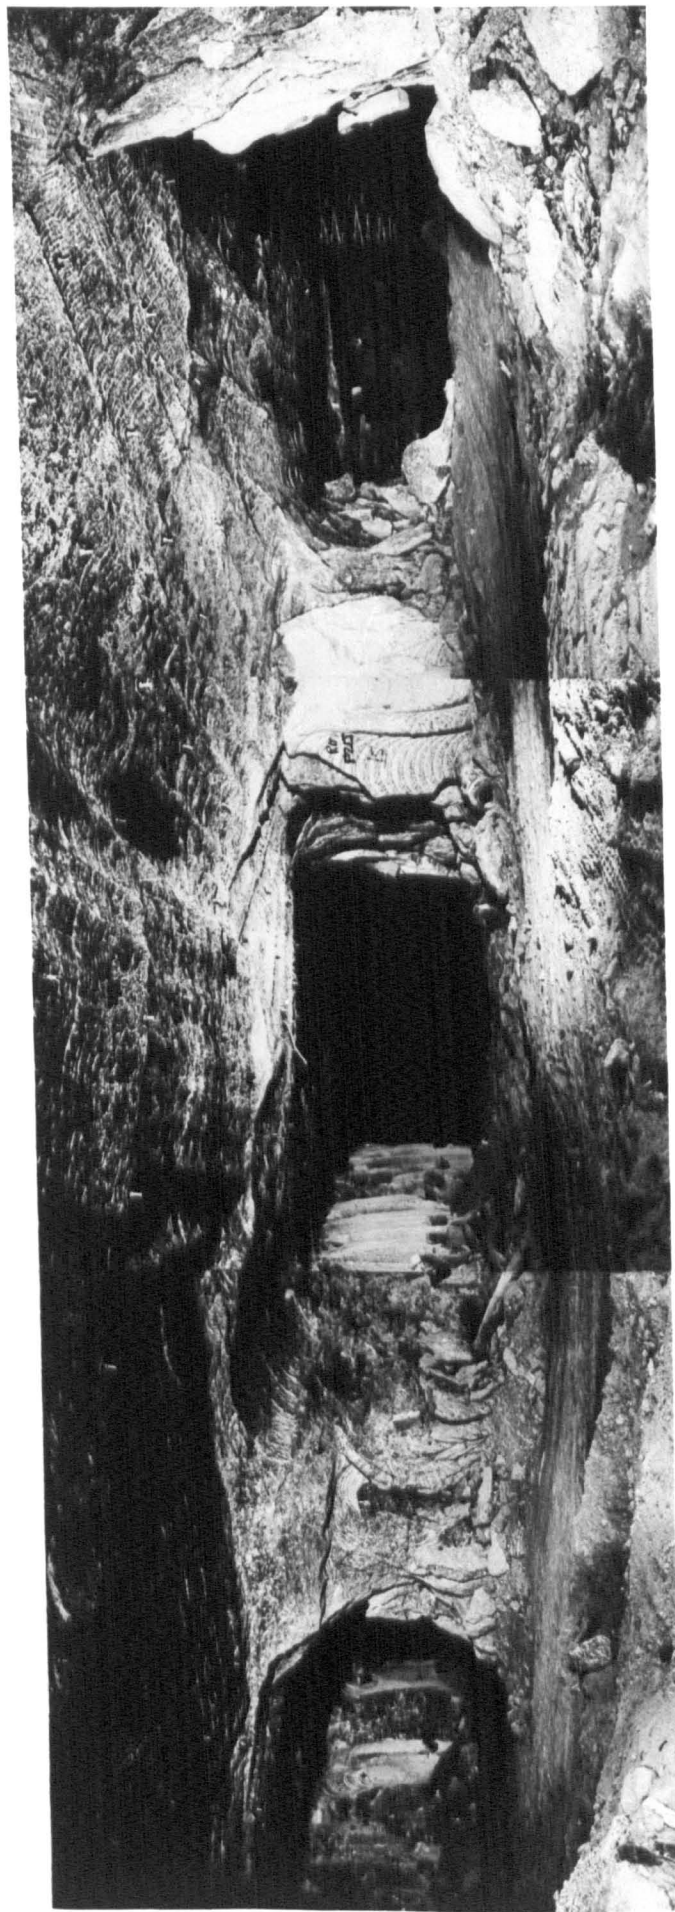
PLATE 1 NO. 22 HIGH EXTRACTION PANEL.

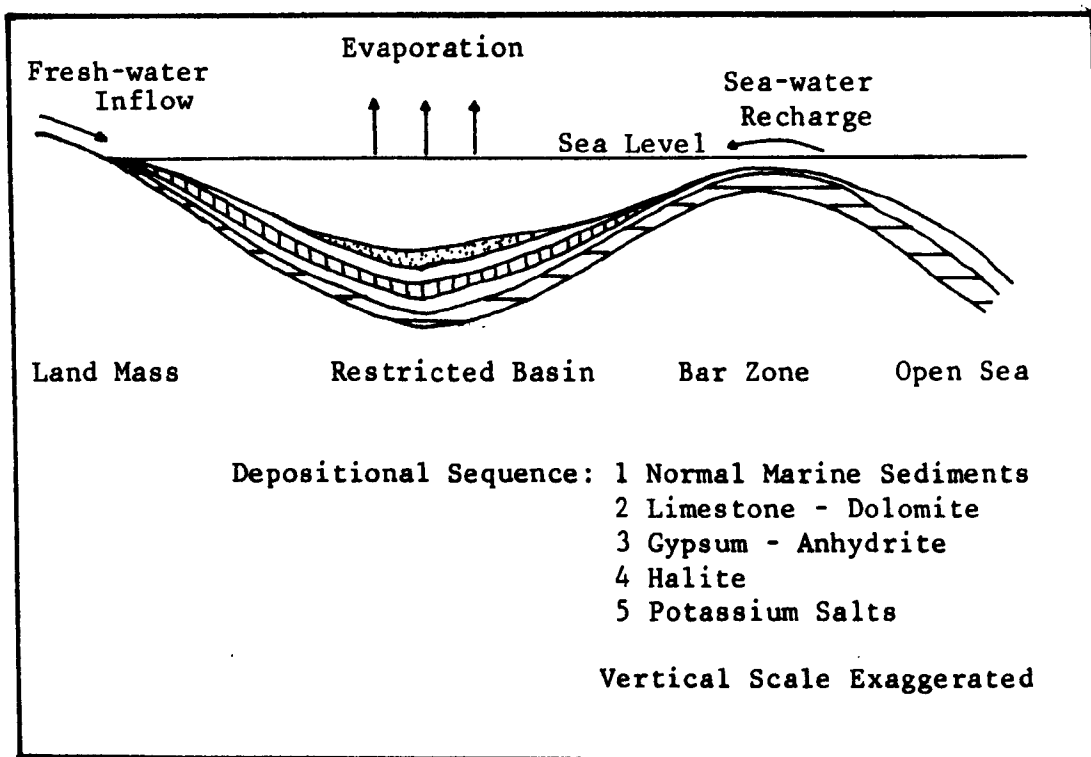
Figure 2.1 Generalised sequence of evaporite deposition

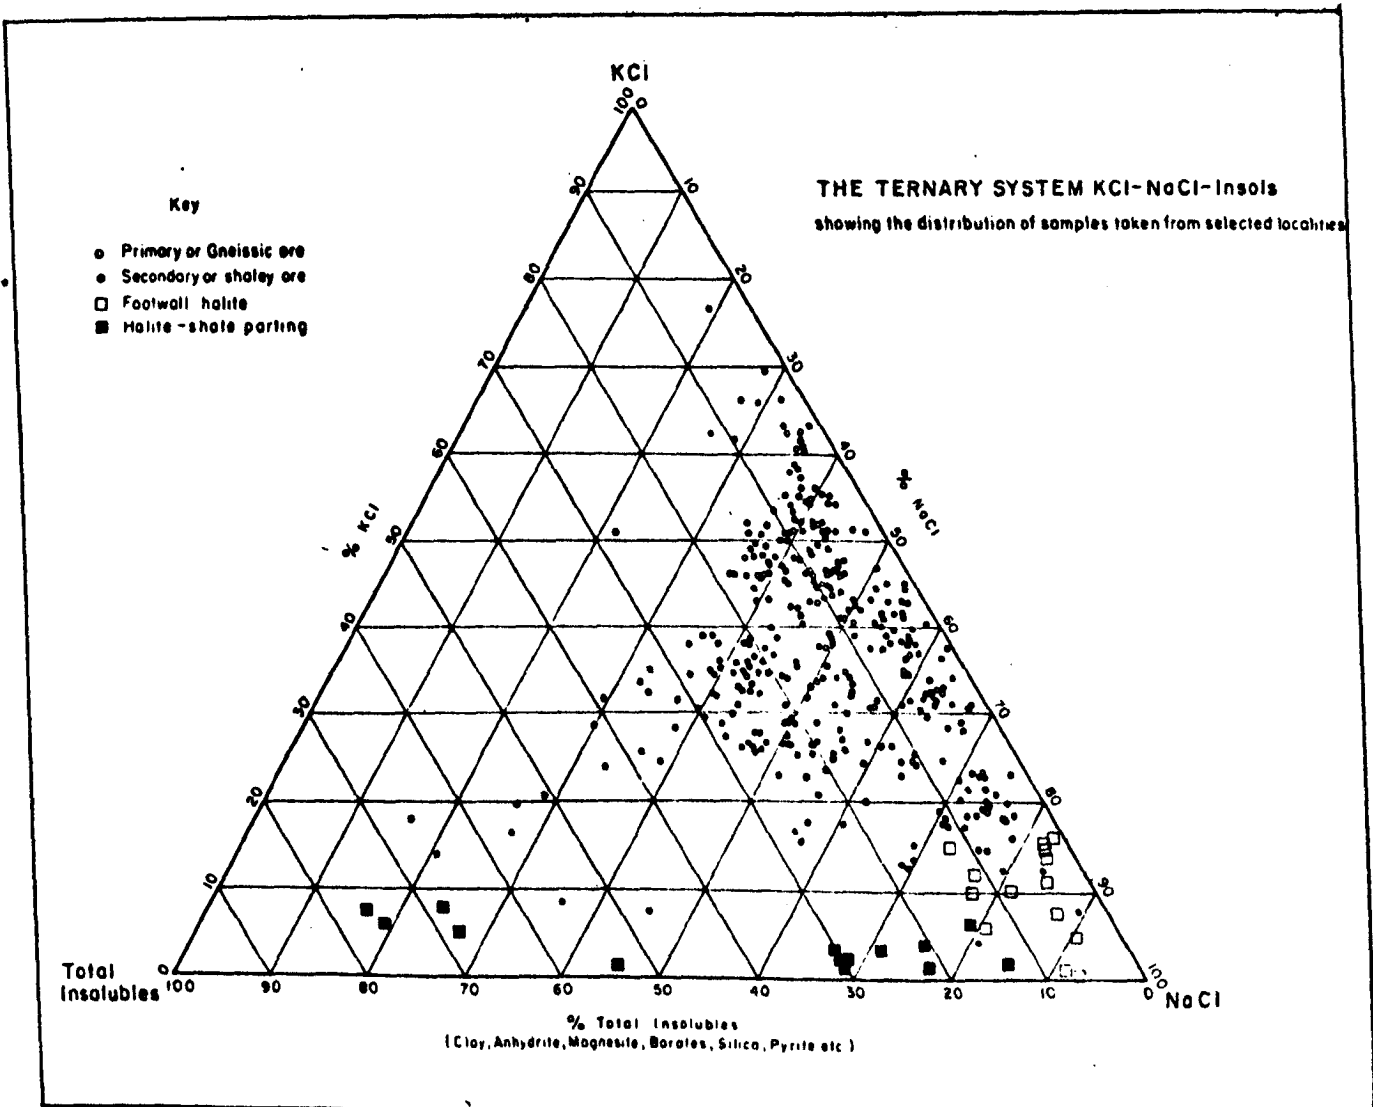
Figure 2.5 Ore type classification (after Hebblethwaite and Woods)

The classification of ore types as proposed by Hebblethwaite and Woods⁽⁹⁾ is given in Figure 2.5. This is based on the three component system, KCL, CaCl and Insolubles content, and was derived specifically for considering the gas blow problem. The necessity for a more comprehensive classification system arose because of the difficulty in differentiating between specific ore types as observed underground. The terms "Primary" and "Secondary" as applied to potash ore, while convenient, tend to be ambiguous, as both terms imply meanings as to both the grade and the geological origin of the ore. The various fields are drawn to a 95% confidence level for four hundred empirical and observational analyses of visibly different ore types.

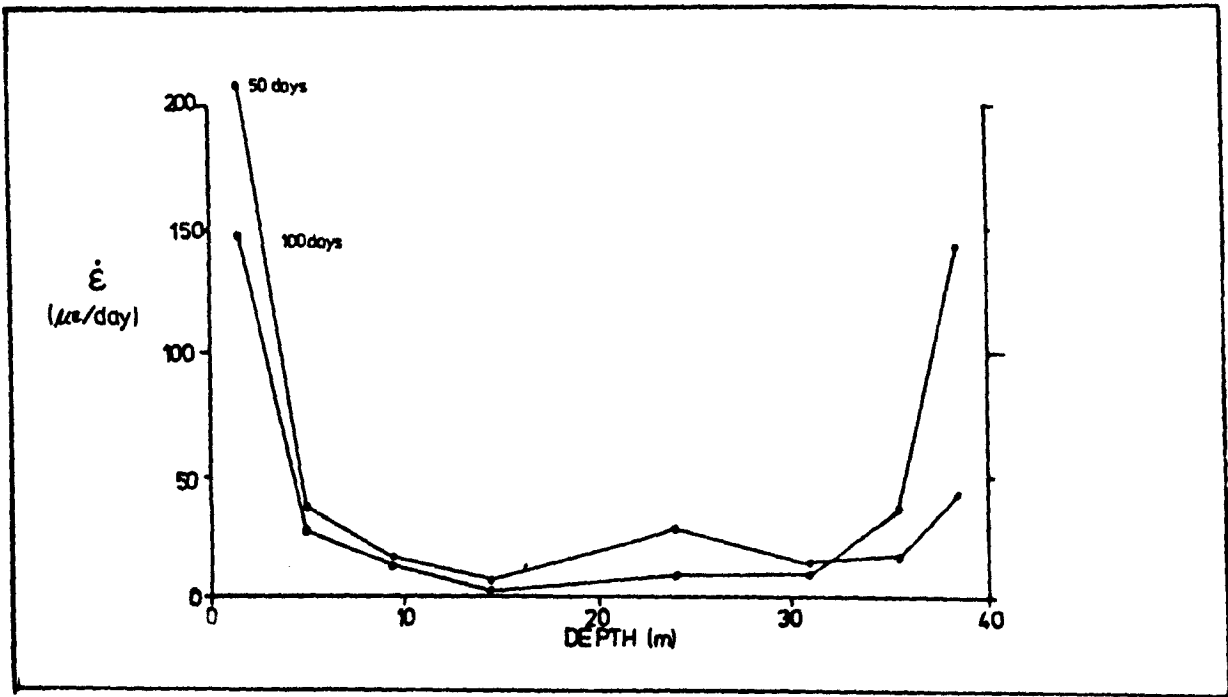
Figure 3.3 Strain rates between J & H roadways, South Development

Rock mechanics sites were established, Figure 3.2a, in the South Development. These gave closure measurements in the roadways and horizontal deformation in the pillars. The results are shown in Figure 3.2b. Figure 3.3 shows the strain rates in the pillar between roadways J and H. This indicates that there is a central stable core in the pillar of 20m to 25m width. Figure 3.4 is a plot of the log strain rate against time for borehole 4 which is in potash, and borehole 8 which is in salt. Although borehole 8 shows some sign of reloading between 80 and 120 days, the negative slopes of both graphs illustrate continuing stability. The greater stability of the pillar in halite is also evident. The linear relationships depicted in Figure 3.4 can be described by the following equations:

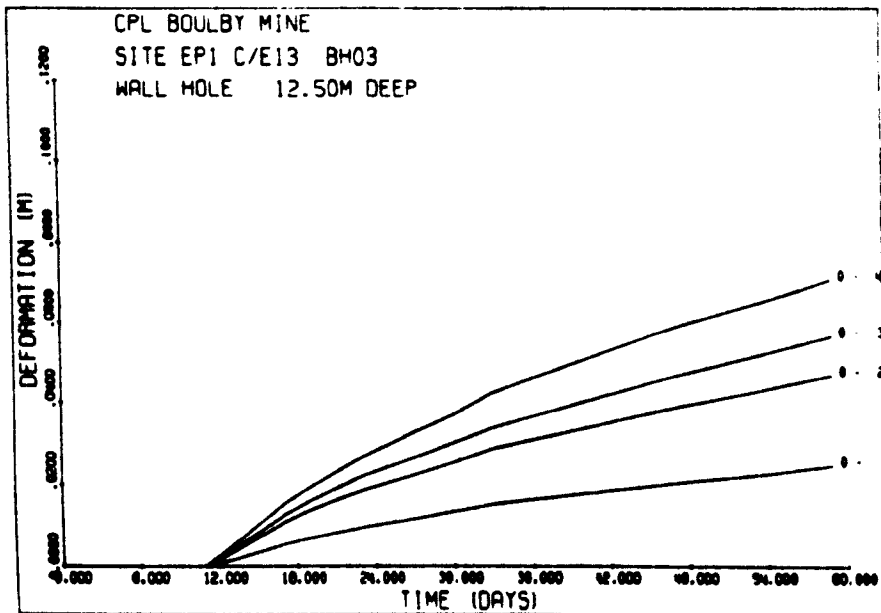
Figure 3.6(a) Pillar extensometer, East Panel

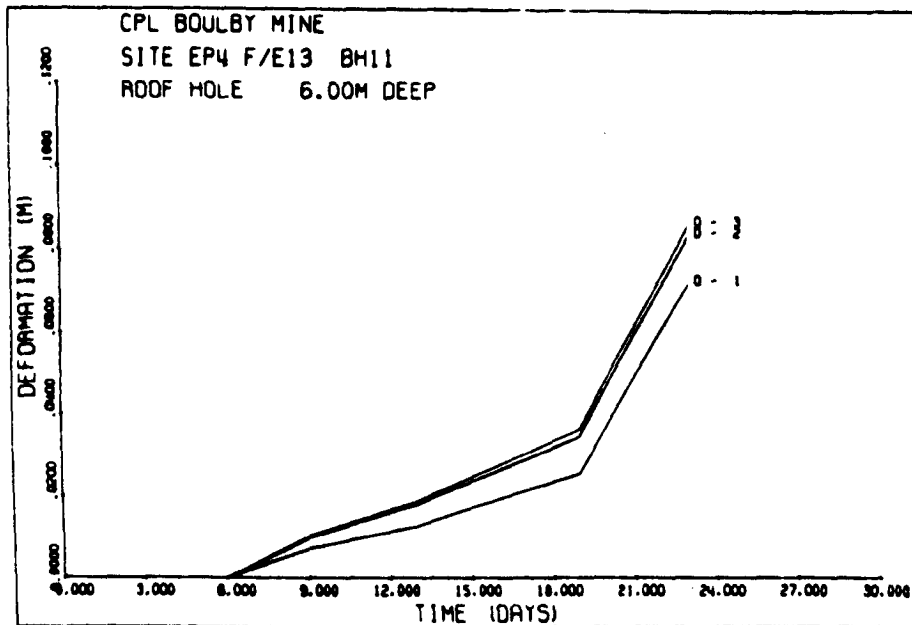
Figure 3.7 Roof extensometer - East Panel

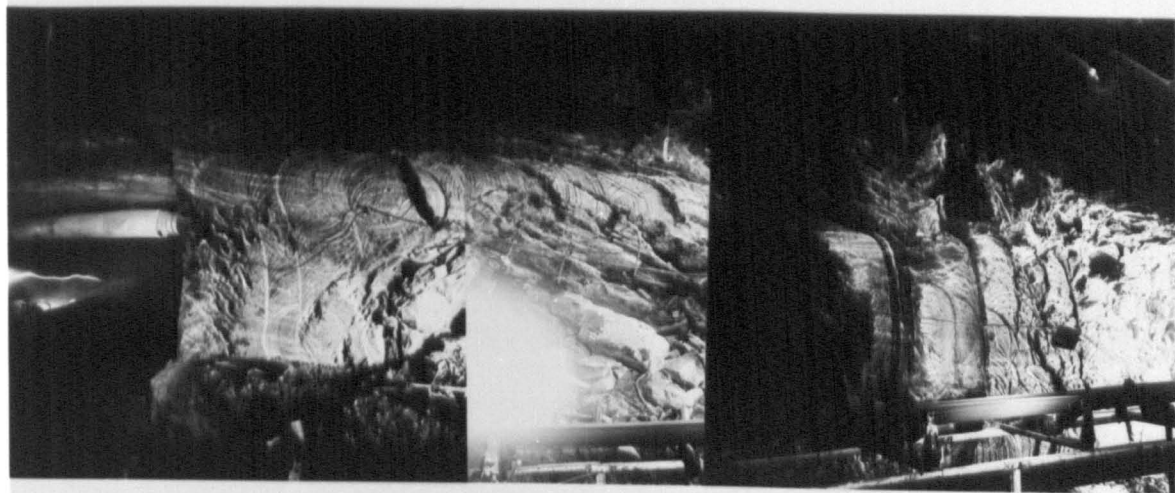
Plate 3.1

- 1 No.7 Panel - old low extraction roadway.
- 2 No.7 Panel - new roadway looking at old workings
- 3 No.7 Panel - old roadway.

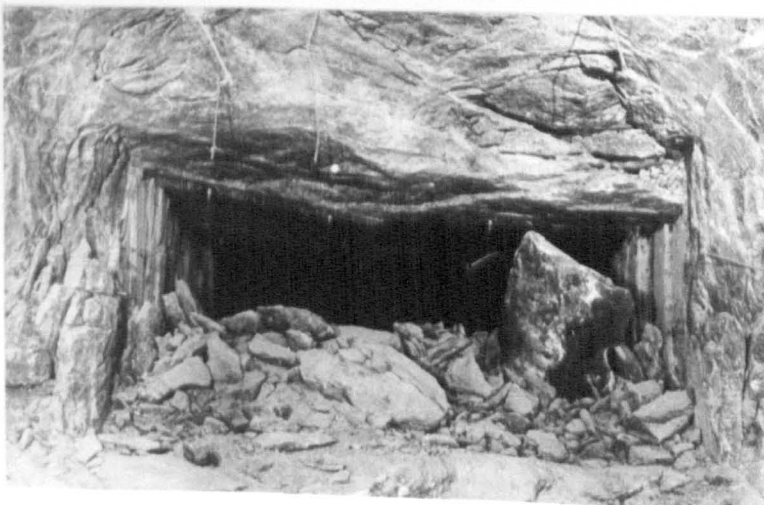
Plate 3.2

- 1 Original roadway in centre showing enlargements by blasting roof and sides.
- 2 Original roadway in centre after enlargement by blasting. Note fracture pattern.
- 3 Close-up of centre road in No.1. Note formation of low angle shear fracture.

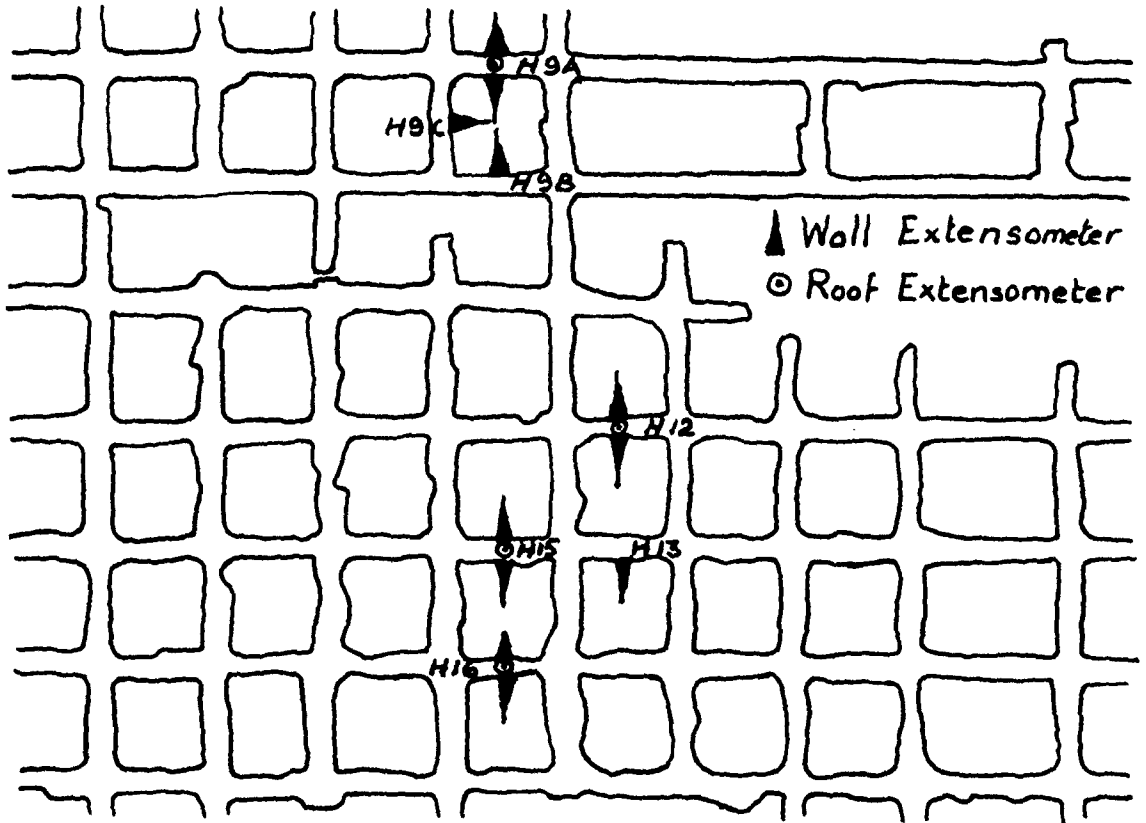
Figure 3.12 No. 6 Panel instrumentation sites

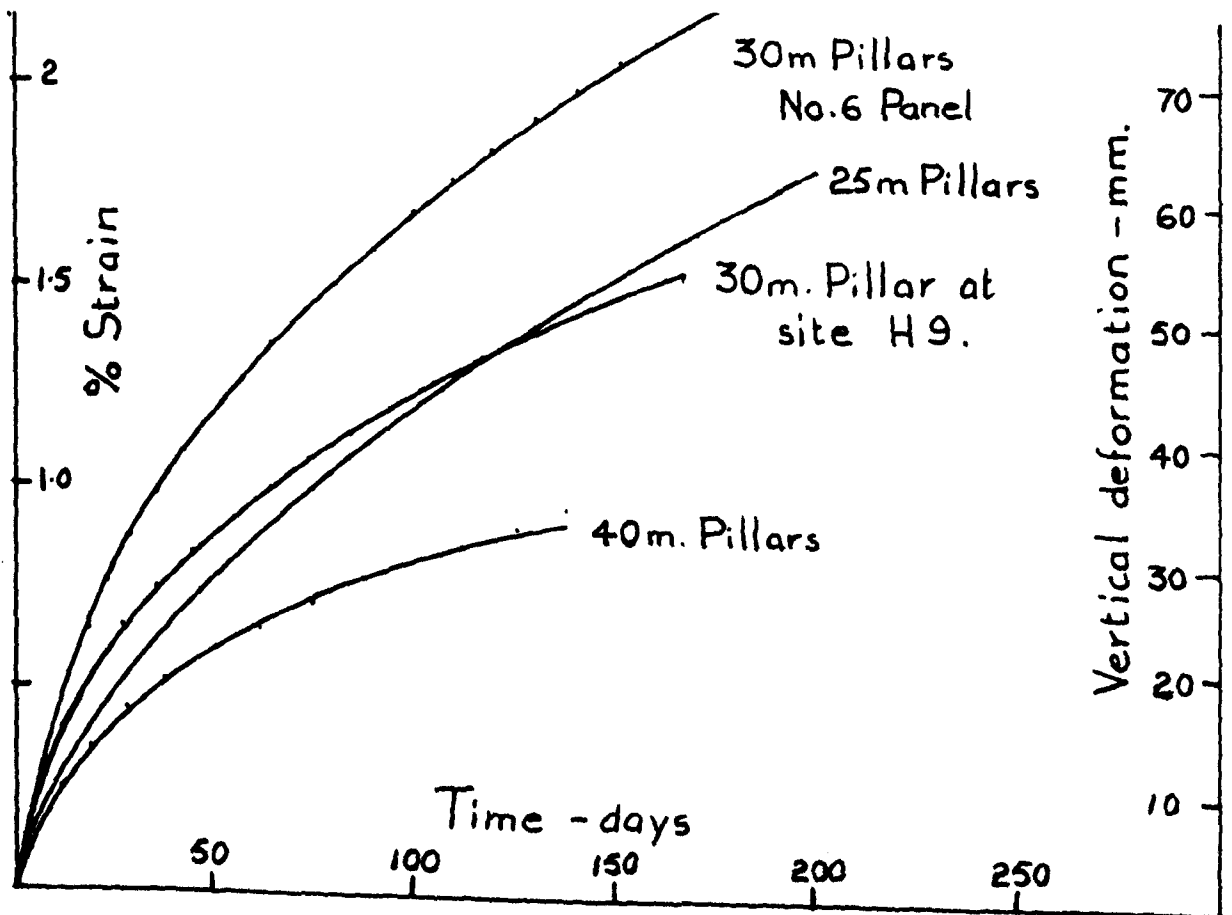
Figure 3.13 Strain rate/time curve for 25, 30 & 40m pillars

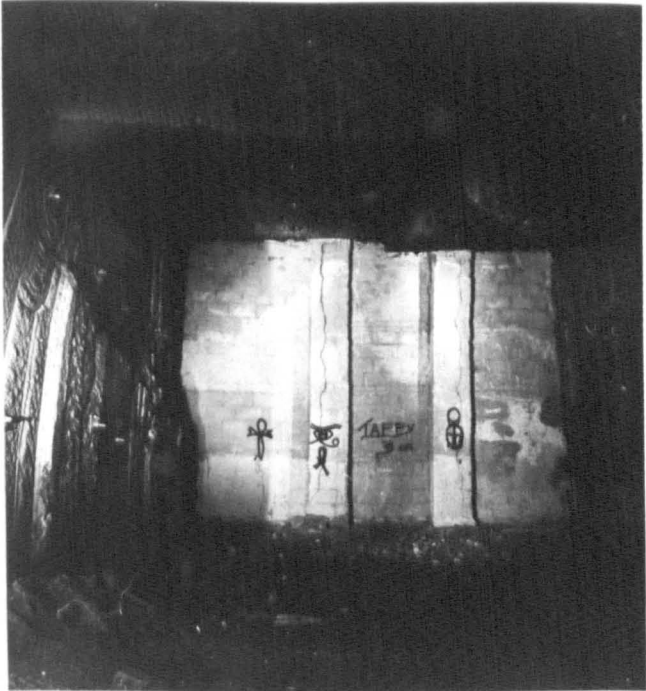
West Link Salt Roads

1. Drill and blast section.
2. Cracks in concrete columns in connecting cross cut.
3. Heliminer driven section.
4. Photoprofile

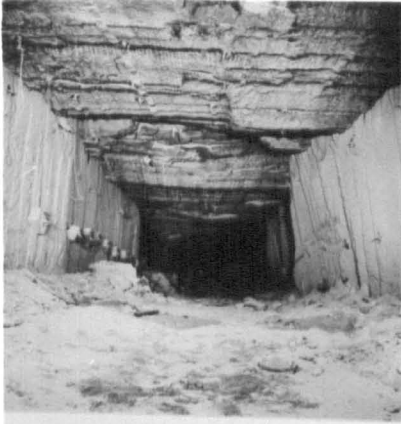
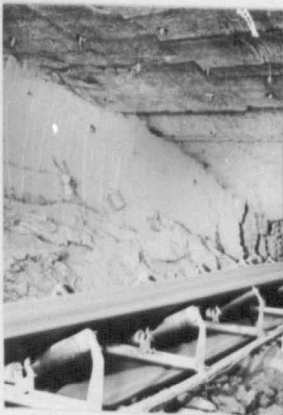
Plate 3.5

- 1 Some roof failure. Vertical shearing in roof down left-hand side - horizontal shearing on right-hand side.
- 2 Profile, roof has had to be ripped, and is failing again. Sidewalls high and in good condition.
- 3 Profile of a C43 Conveyor road.
- 4 C43, 9m wide - good roof, plenty of room for subsequent sidewall movement.
- 5 Extensive roof failure. Note support not much use.
- 6 Panoramic view down 4m wide yield pillar.

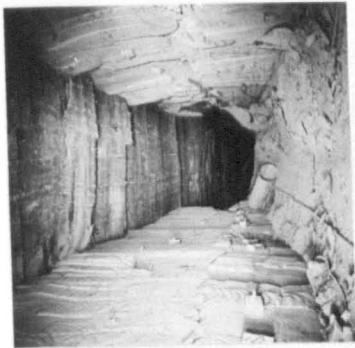
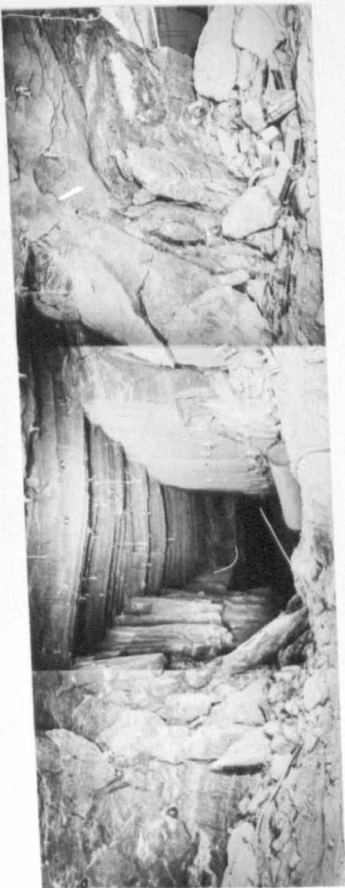
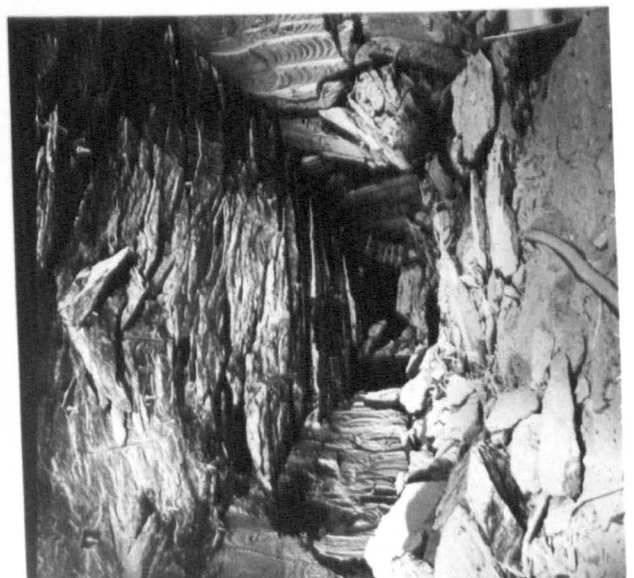
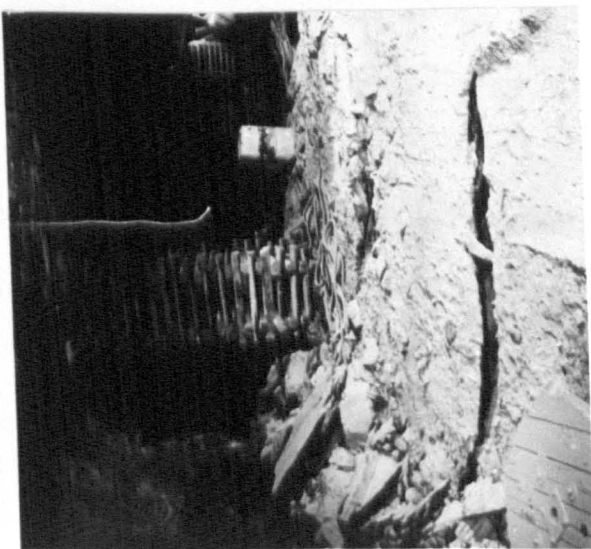
Plate 3.7

- 1 Same as 3 some 6 months later. Note increase in all round failure. Effect least on sidewall of large pillar (right). Contrast with conditions in 1.
- 2 One of the rare occurrences of footwall heave.
- 3 Extensive roof failure.
- 4 4m wide yield pillar showing yield at pillar end. Contrast with 4.

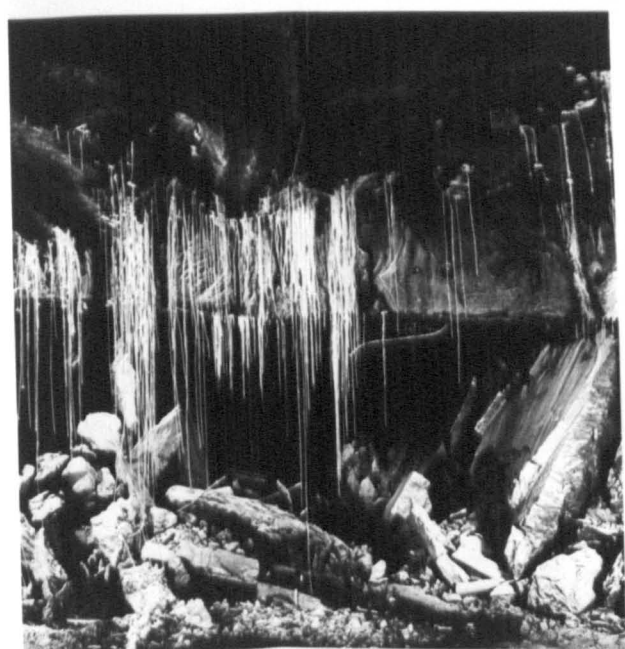
Plate 3.8

- 1 Roof in good condition, pillar failed.
- 2 End-on view of 4m yield pillars.
- 3 Site showing roof relatively intact, extensive
sidewall failure due to high closures. E road water sites.
- 4 Good conditions in the stub at water site.
- 5 Top corner in stub showing increasing amounts of
vertical shears.

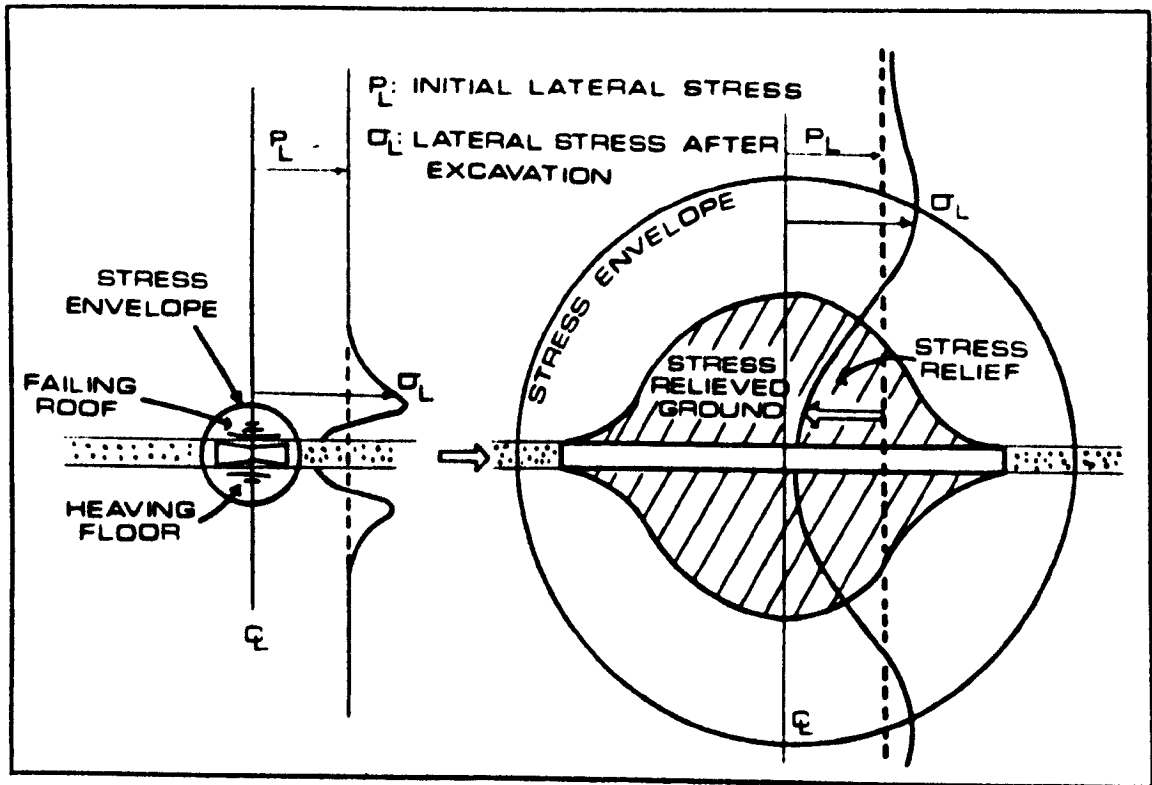
Figure 4.2 Stress Relief - Serata

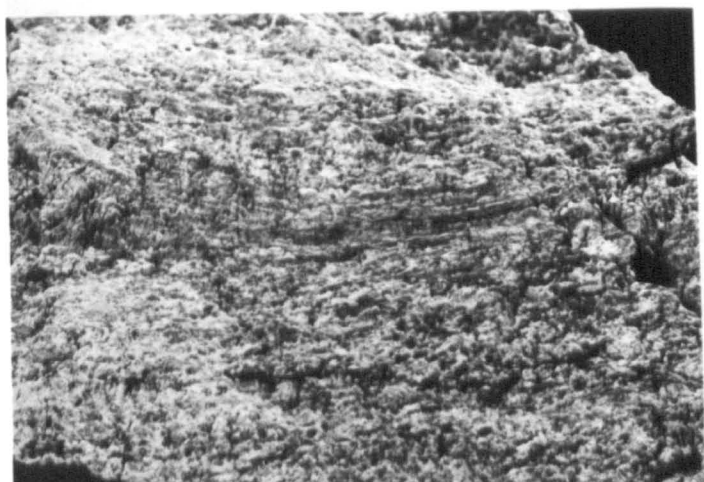
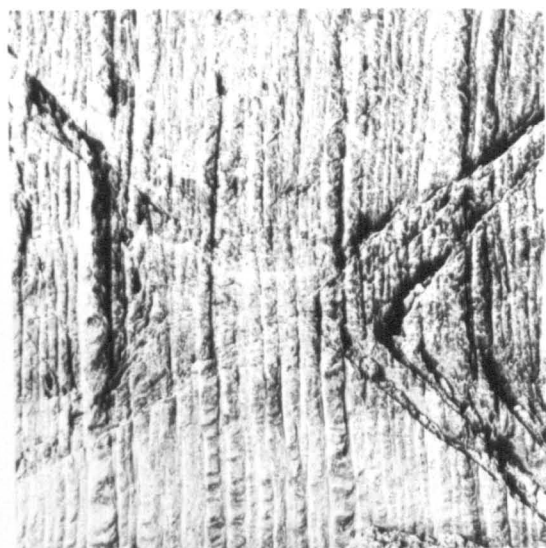
Plate 4.2

- 1 Showing extensive sidewall fracturing with formation of elliptical opening.
- 2 Low angle fracture and sidewall slabbing leading to elliptical shape in salt roadway.
- 3 Brine weeping from rockbolt holes in salt road after entry of water in No.12 Panel.
- 4 Wet patches on roof of salt roadway. Note failure of sidewalls indicating high loading on this section of salt roadway.

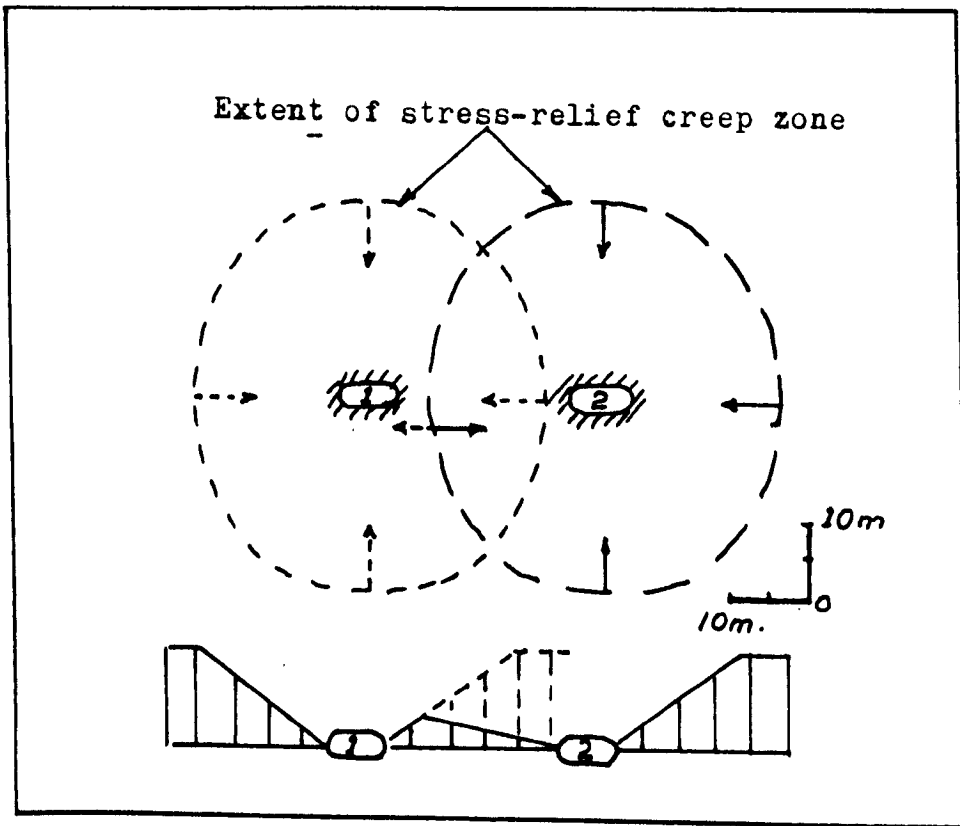
Figure 4.5 Stress-relief - Baar

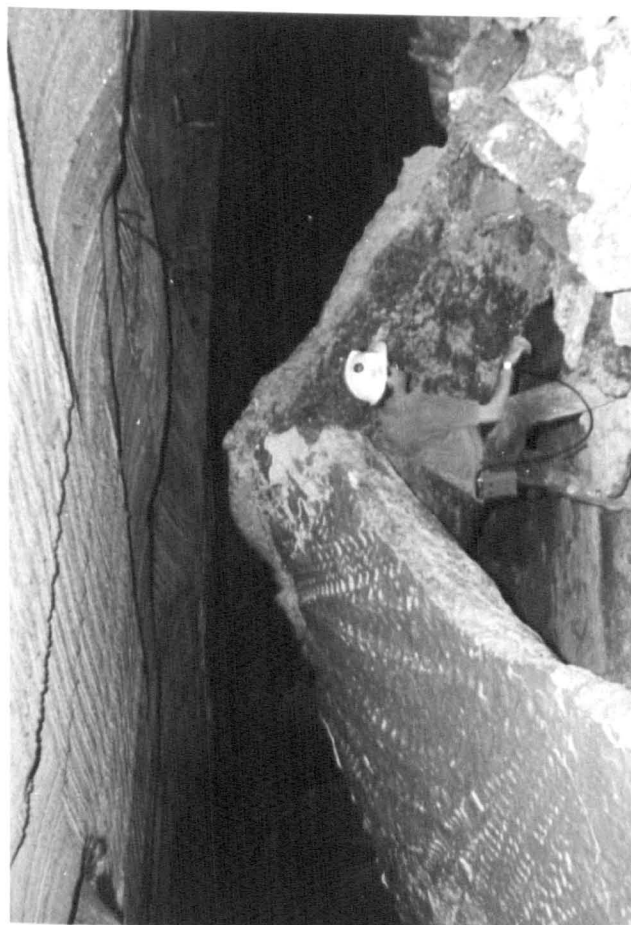
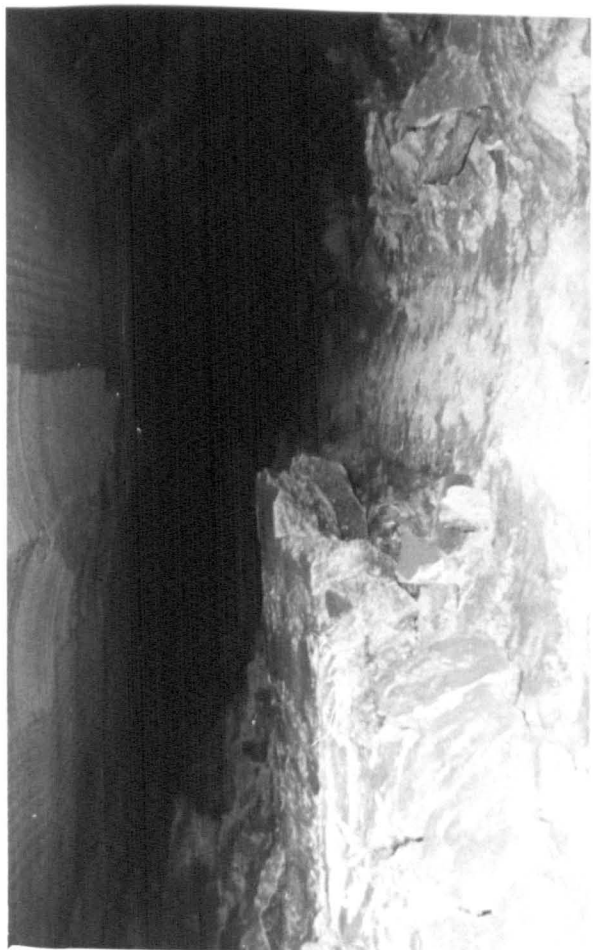
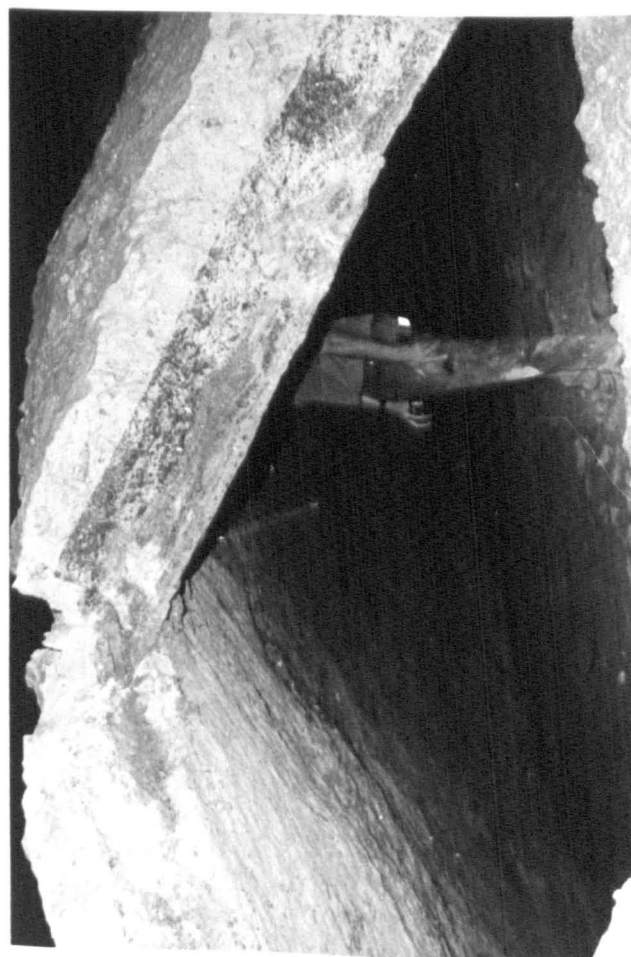
Plate 4.3

Footwall heave in a Canadian Potash Mine.

encountered in Canadian potash mines is floor heave - see Plate 4.3. The major points of variance that arise between Serata and others, can be summarised in the form of a number of questions:

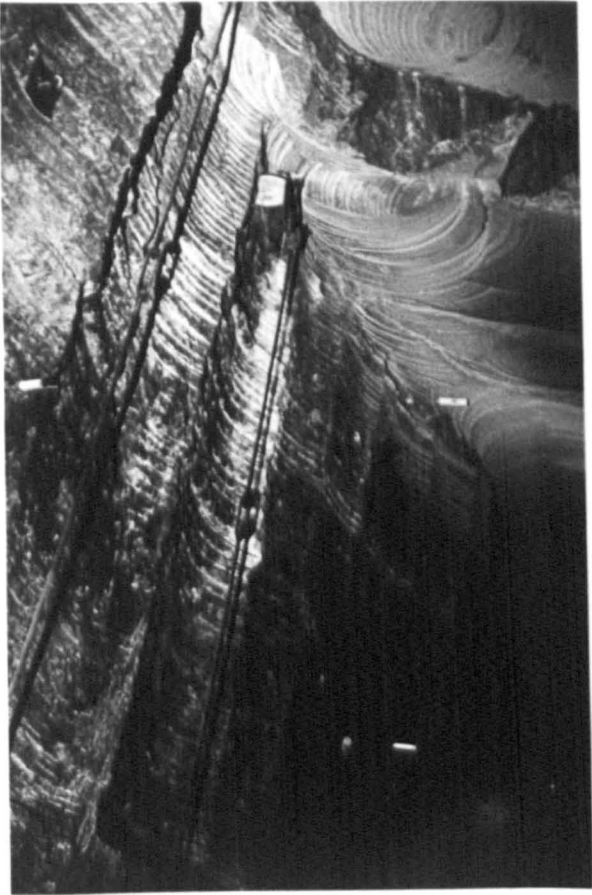
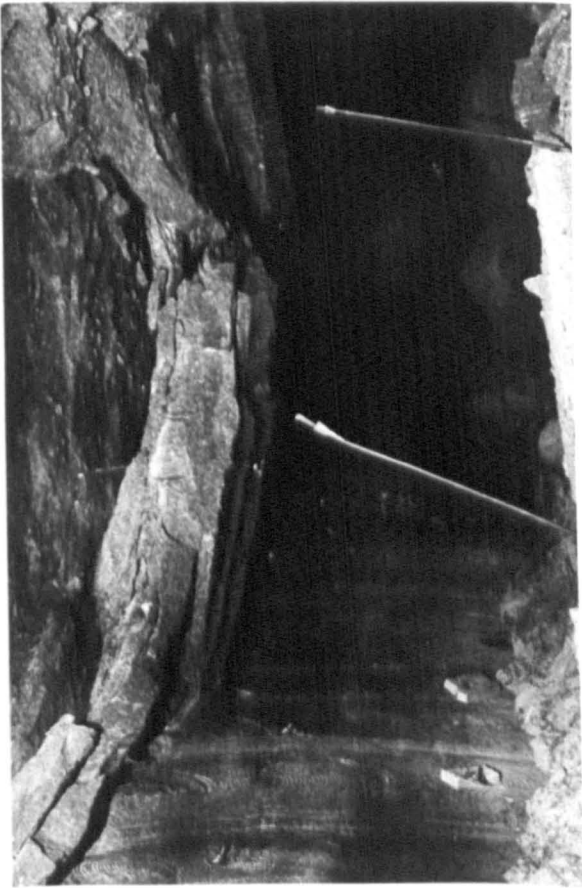
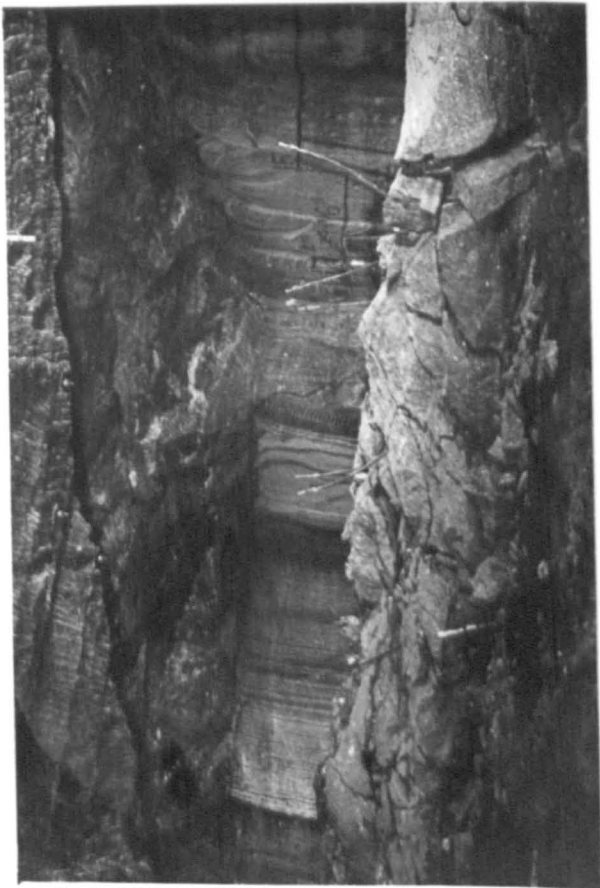
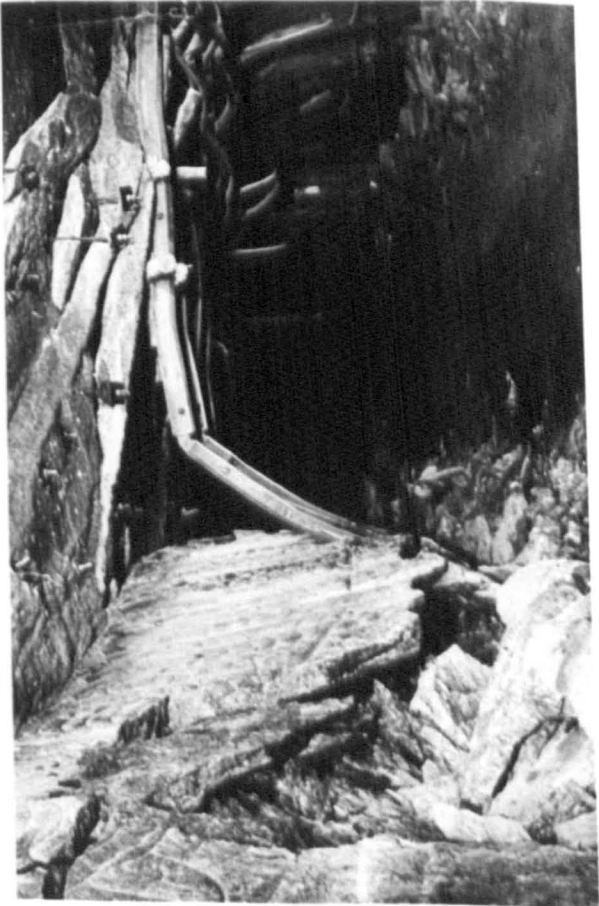
Plate 5.3

- 1 Roof collapse along geological discontinuity. Note roof bolts pulled out.
- 2 Experimental roof 'truss bolts'.
- 3 Steel arch sets coping with extensive sidewall and roof failure.
- 4 Roof slabbing, mechanical anchors pulled out.
Notr good sidewall.

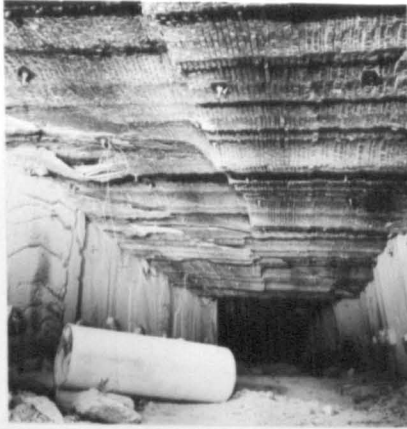
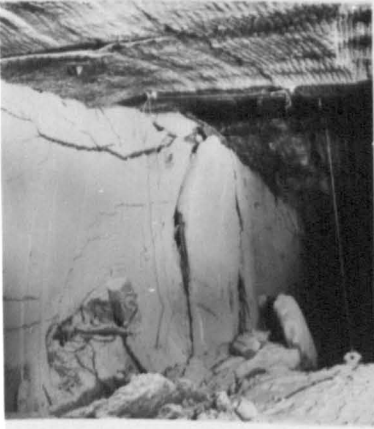
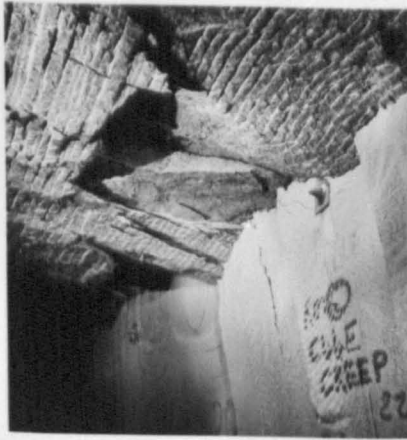
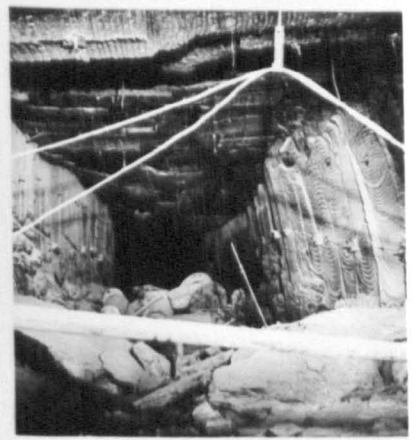
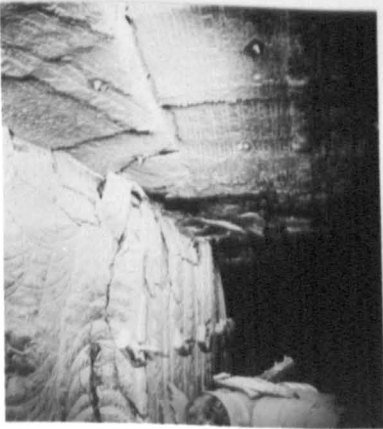
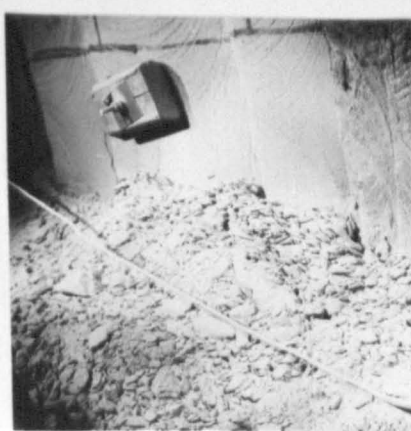
Plate 5.4

- 1 Pure sylvite (white) in high grade but increasingly geologically disturbed zone. Face after profiling with Heliminer.
- 2 Face marked for drilling and drill at left.
- 3 Undercut slot, face drilled for blasting.
- 4 Face after blasting.

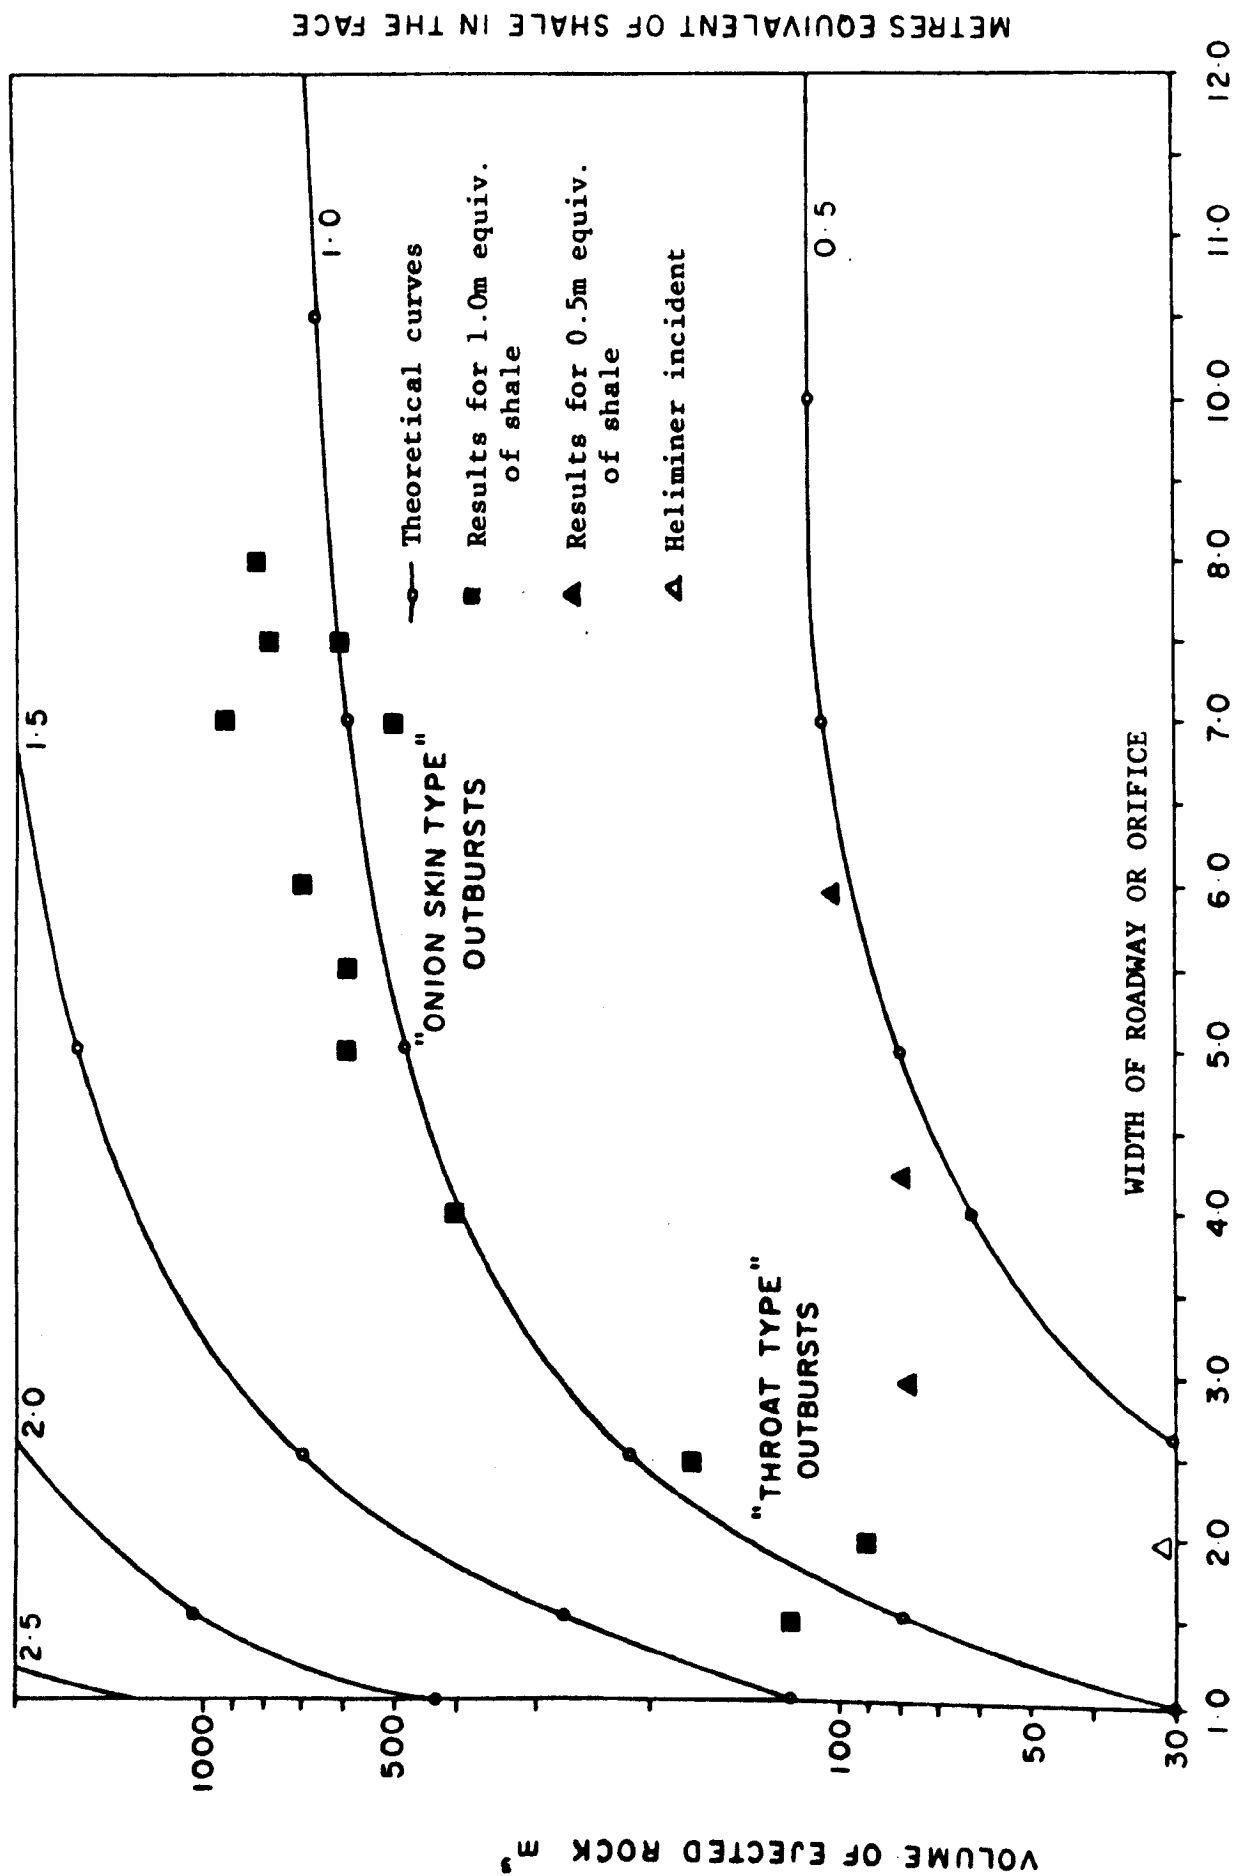
Figure 5.5 Relationship between outburst tonnage, and roadway width

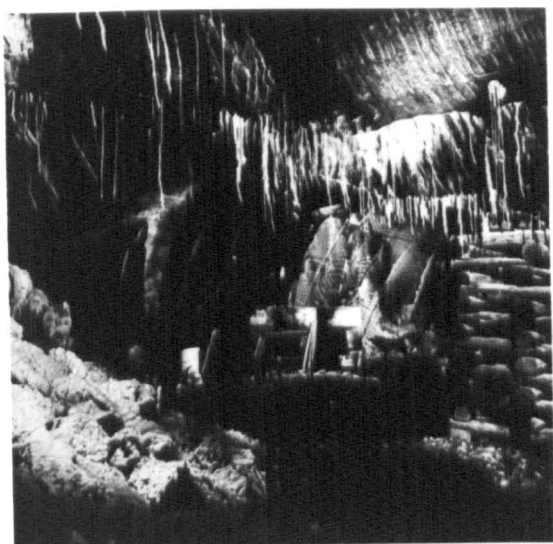
Plate 5.5

Showing different views of water ingress site.
No 3 shows the vertical shear fracture running
along the roof across the mouth of the stub.
Conditions in the stub were good.
