STABILITY OF EXCAVATIONS AND DESIGN OF MINING

LAYOUTS IN A DEEP LEVEL POTASH MINE

A THESIS

H.D.S. MILLER B.Sc., (Wales)

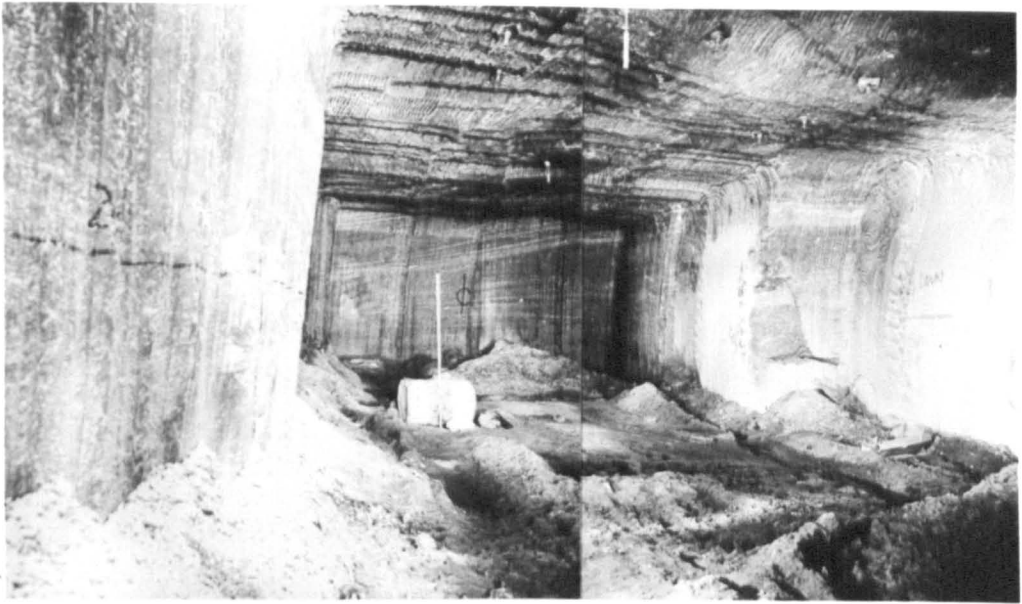
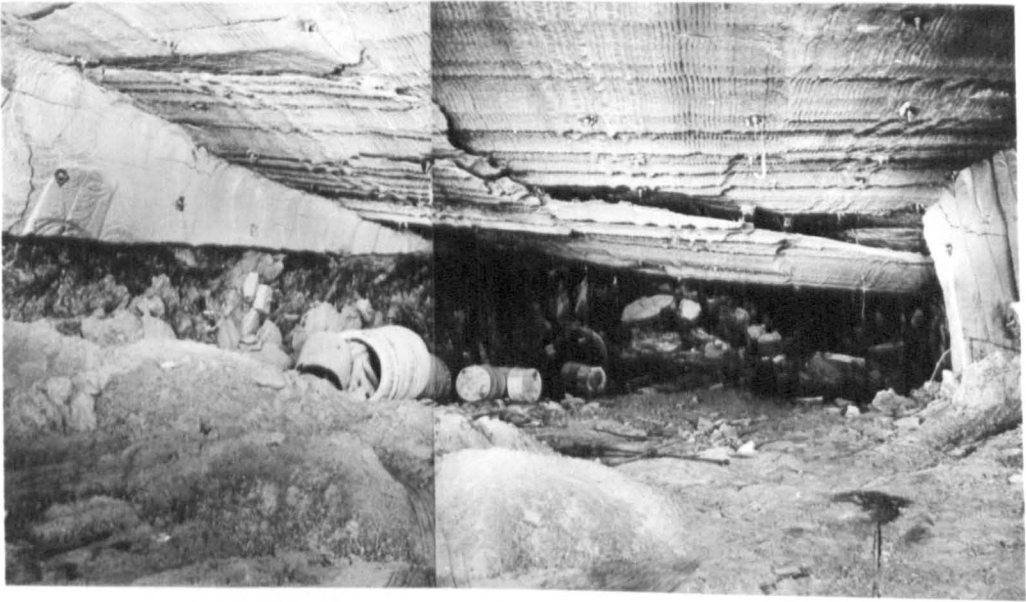
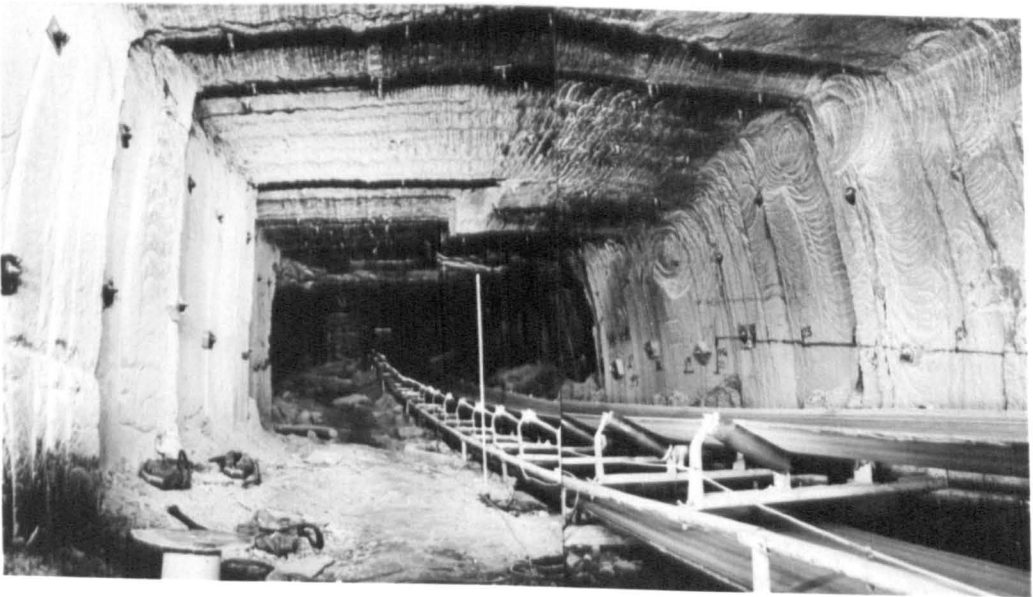
- 1 Newly mined heading in good primary ore.
- 2 Roadway coming up out of salt into potash, with extensive roof slab. Note that it is the halite that has broken away on the sidewall due to its lower failure strain.
- 3 C43 Conveyor road approximately 15 days after mining - excellent conditions.

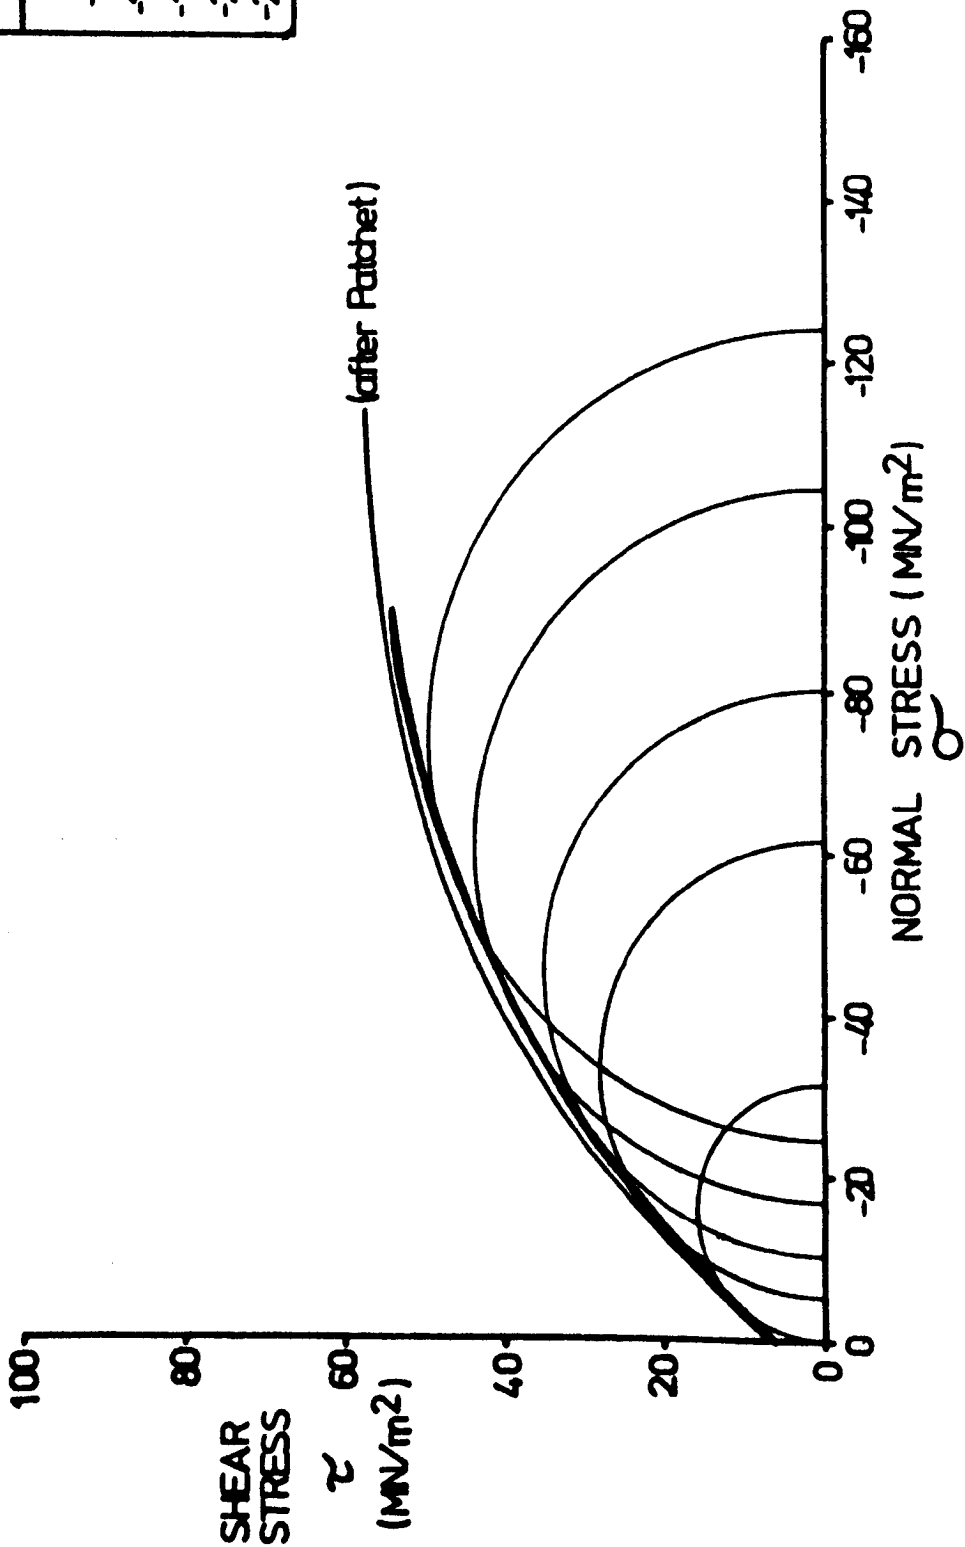
Figure 6.1 Mohr's Envelope for Potash

σ_3	$\sigma_1(\text{fail})$	ϕ°
0	-32	53
-5	-61	45
-10	-80	42
-15	-95	40
-20	-112	37
-25	-125	35

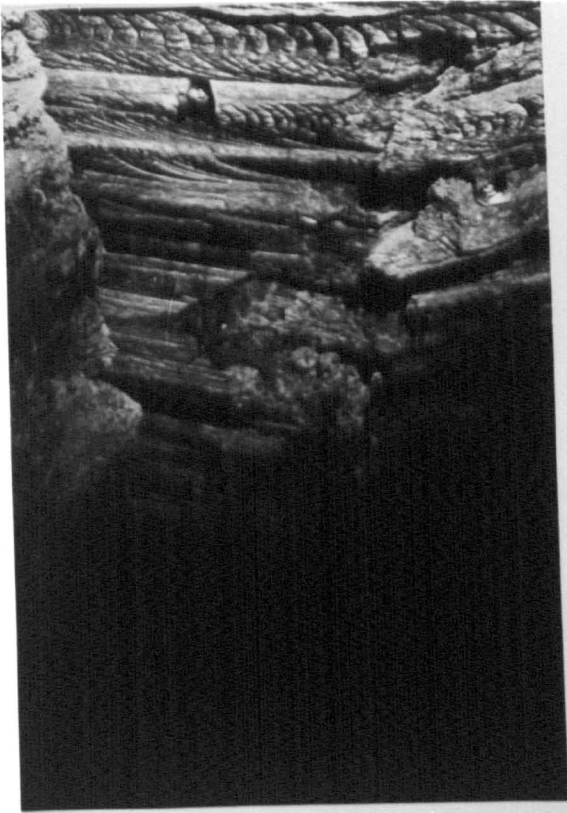
- 1 View down A roadway.
- 2 View down C roadway.
- 3 E roadway 25m in from start of panel.
- 4 Vertical shearing along ribside abutment in E roadway.

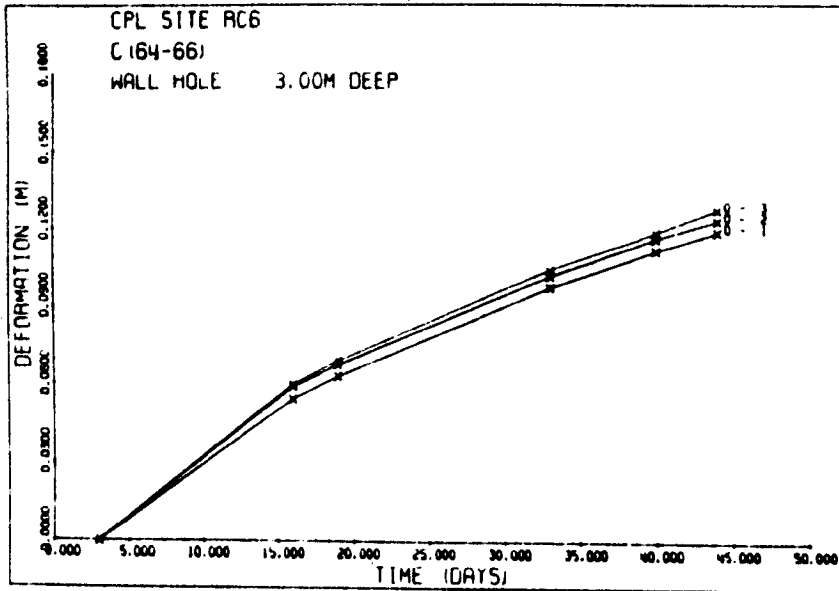
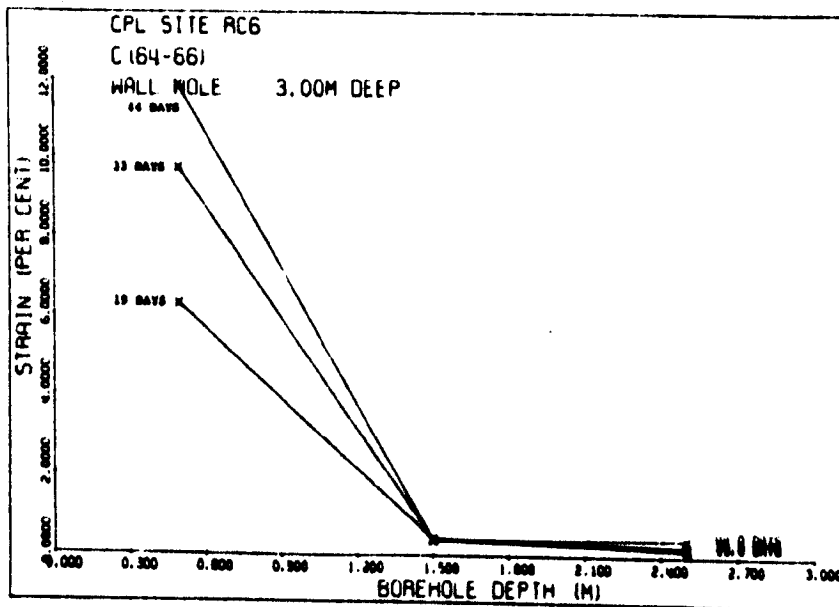
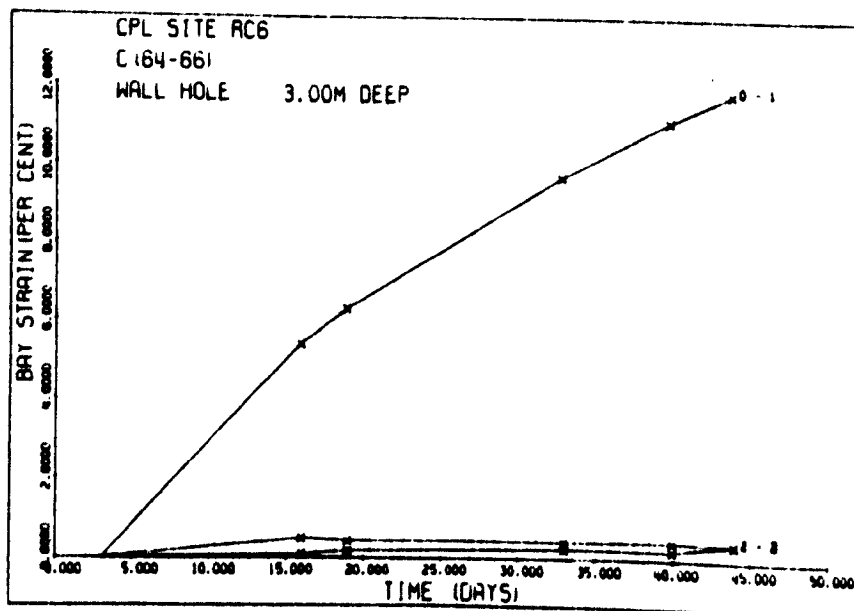
Figure 6.8 No. 8 Panel - Site RC6 pillar extensometer

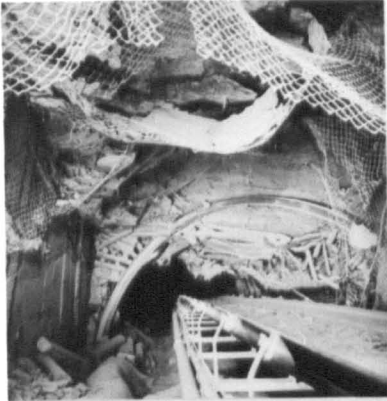
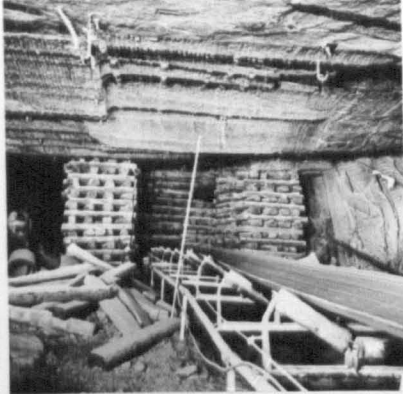
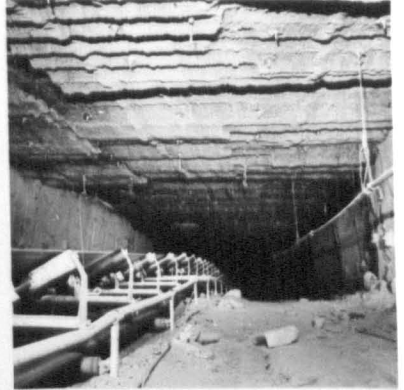
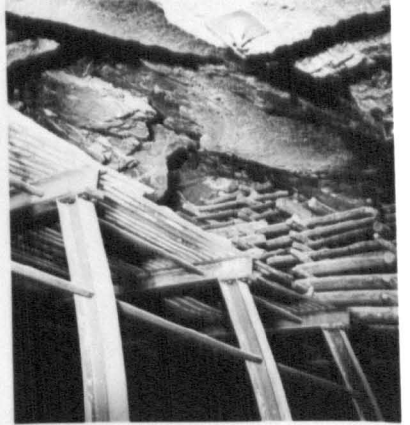
Plate 6.5

- 1 Extensive roof failure in low extraction section. Sidewalls relatively intact.
- 2 Start of high extraction section.
- 3 High extraction section looking in the opposite direction to No.2. Excellent conditions.
- 4 Note 'chipping' at bottom of right hand wall, coming from the movement and failure in the upper corner.
- 5 Roadway profile.
- 6 Extensive roof failure due to proximity to marl. Marl exposed.
- 7 Sidewall failure of yield pillar. Usefulness of 9m wide conveyor road.

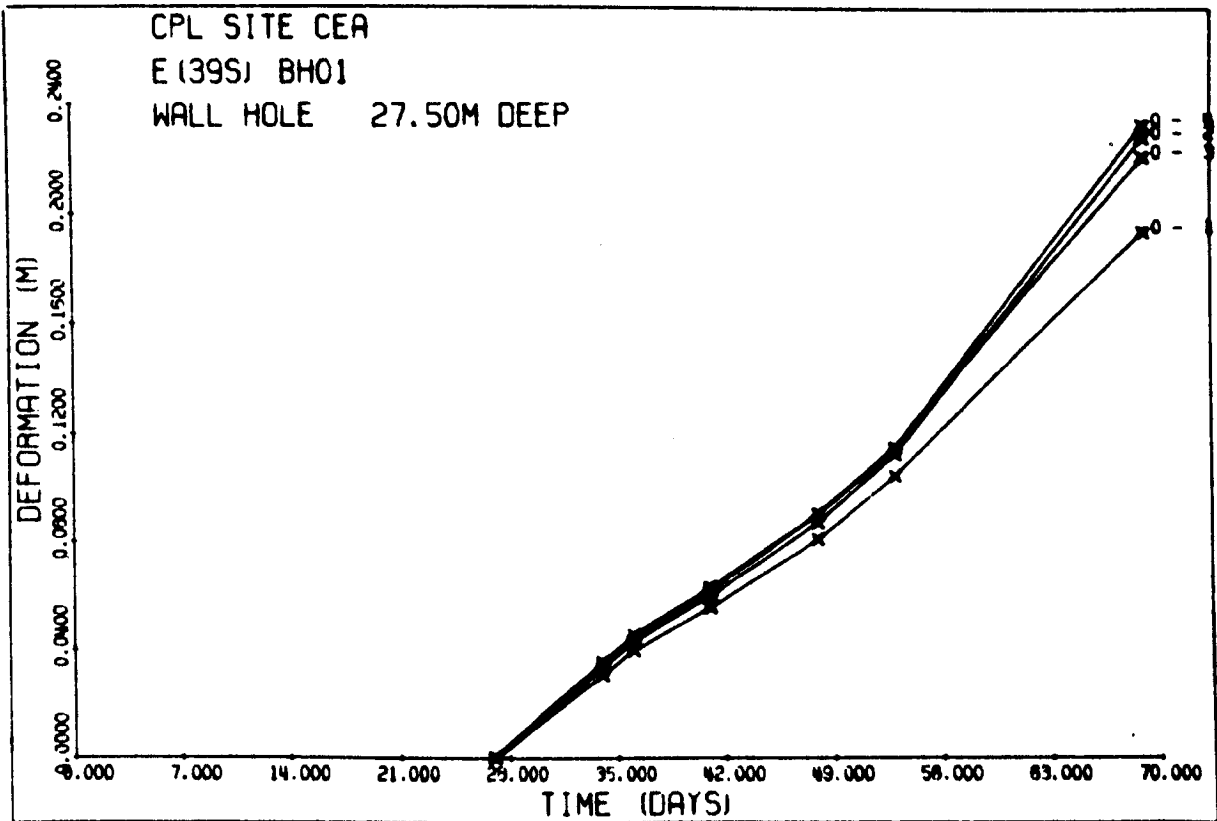
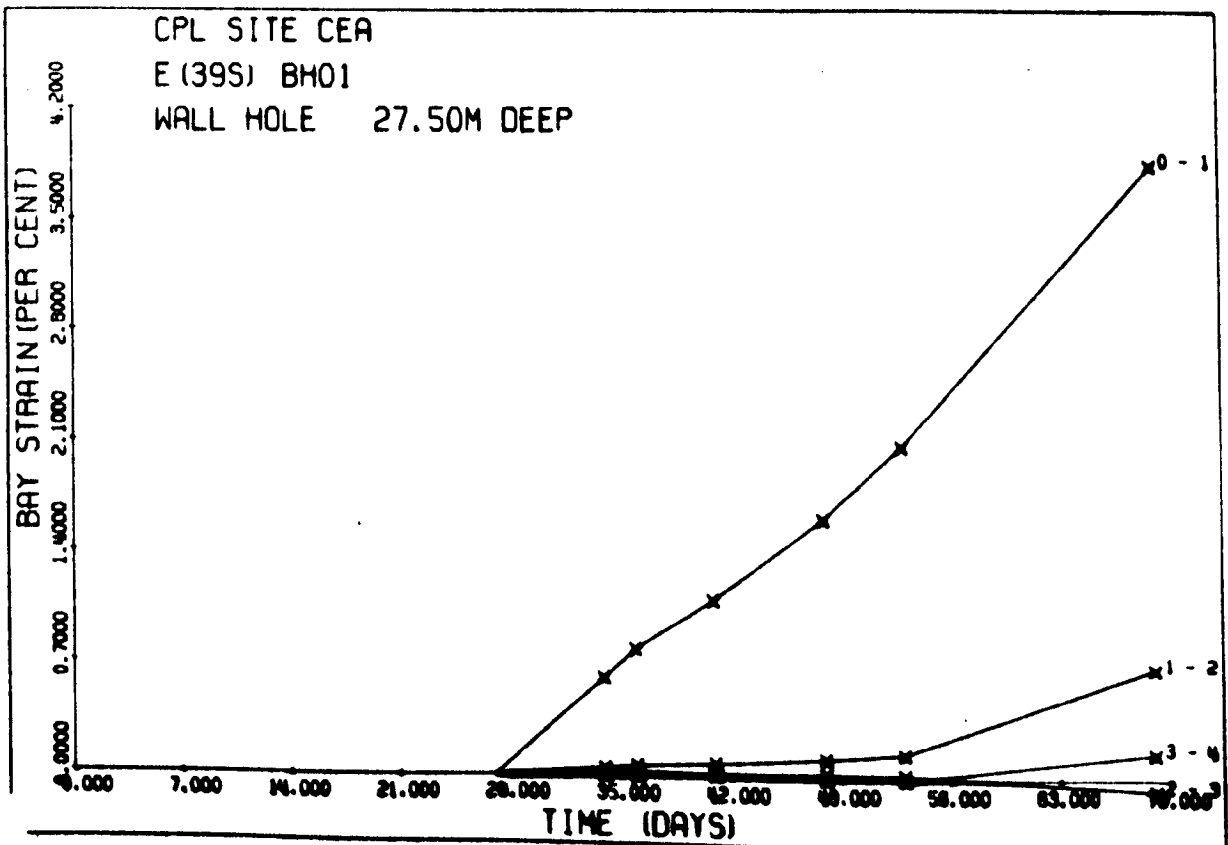
Figure 6.13 No.10 Panel, Site CEA BH1

The graph of log strain rate against time shows an increasing strain rate virtually from when the instrument was installed. This is particularly noticeable in the deeper bays where a fairly significant increase in strain rate begins to take place some 42 to 48 days after mining, by which time the panel had advanced some 60m. Water entered the mine in H roadway 54 days after mining and in E road 55 days after mining of the CEA site.

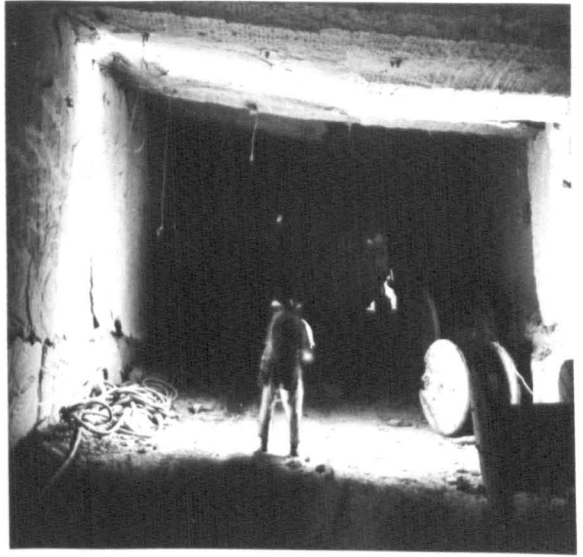
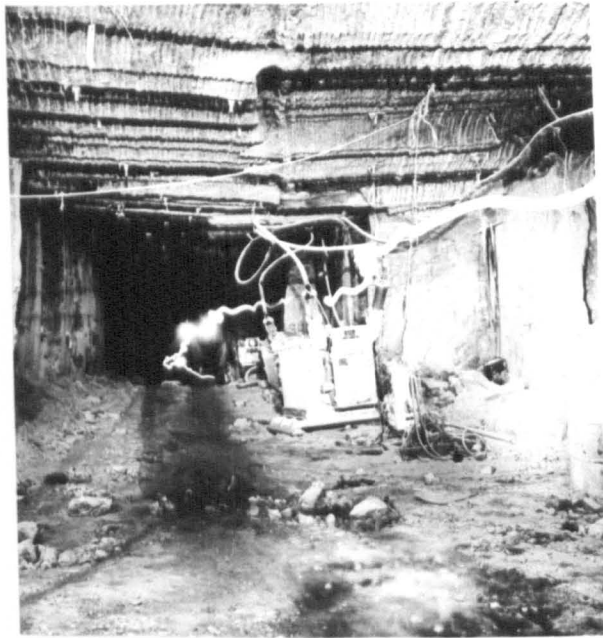
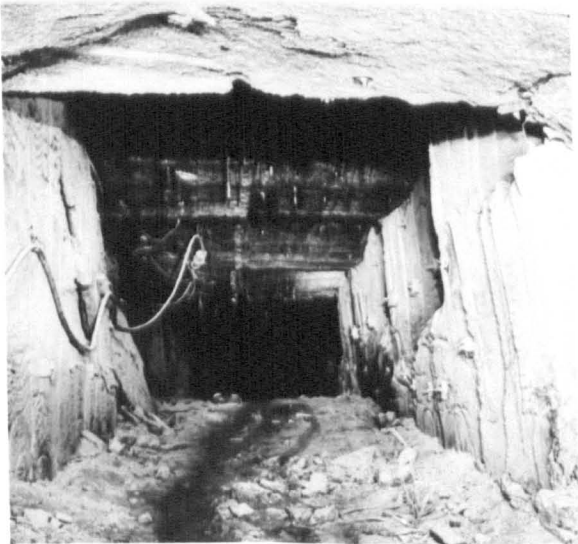
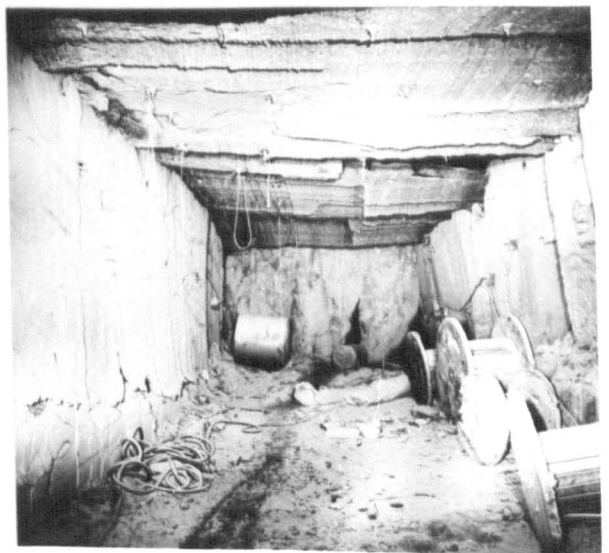
Plate 6.6

- 1 Profile using stationery cap lamp exposure. Note good conditions - no stress relief although slight roof slabbing.
- 2 Note good roof and sidewalls.
- 3 Slight sidewall break-up - sidewalls high.
- 4 Same view as No1 and No2.

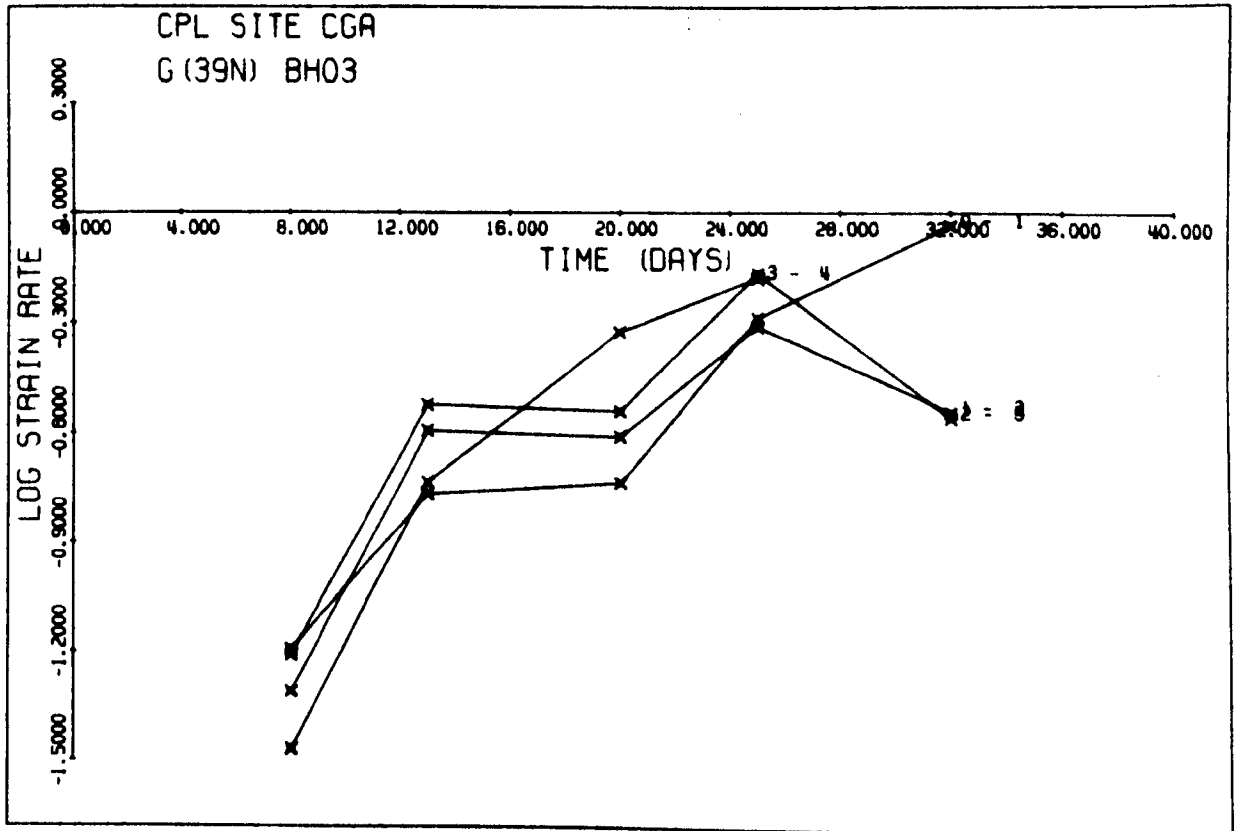
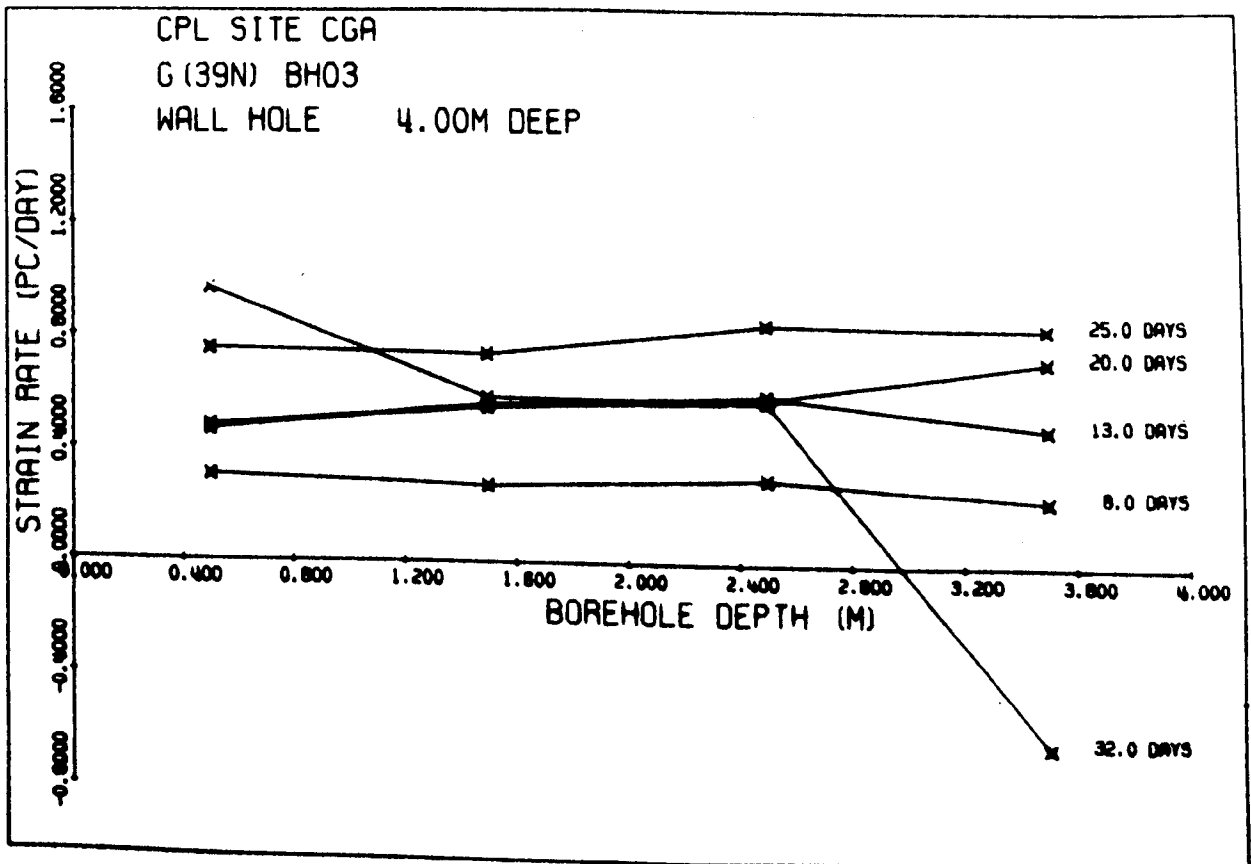
Figure 6 .19 No. 10 Panel CGA BH3 (Contd.)

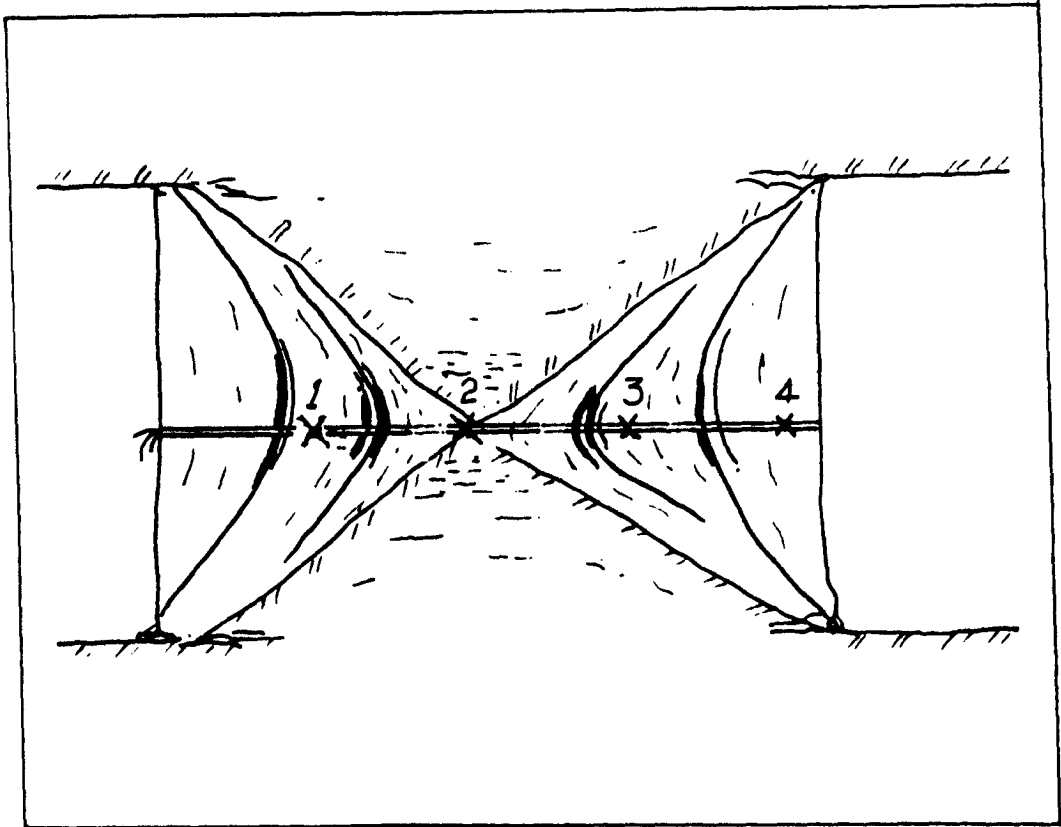
that the anchors must be located as in Figure 6.20. That is virtually through the centre of the pillar. The high strains all well in excess of 2% after 8 days or possibly sooner, further suggest that this pillar is failing, not by plastic deformation, but by vertical fracturing throughout.

Figure 6.20 Nq. 10 Panel, site CGA BH Ø3 - diagram showing anchors in relation to fracturing

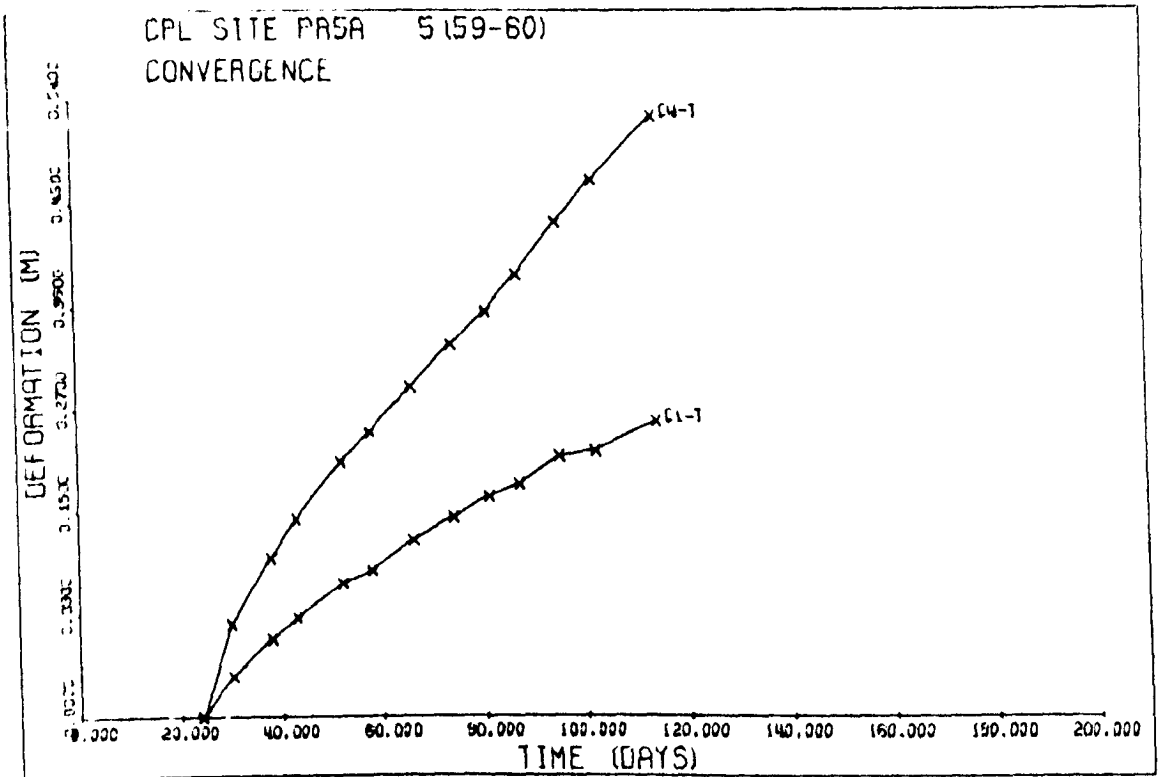
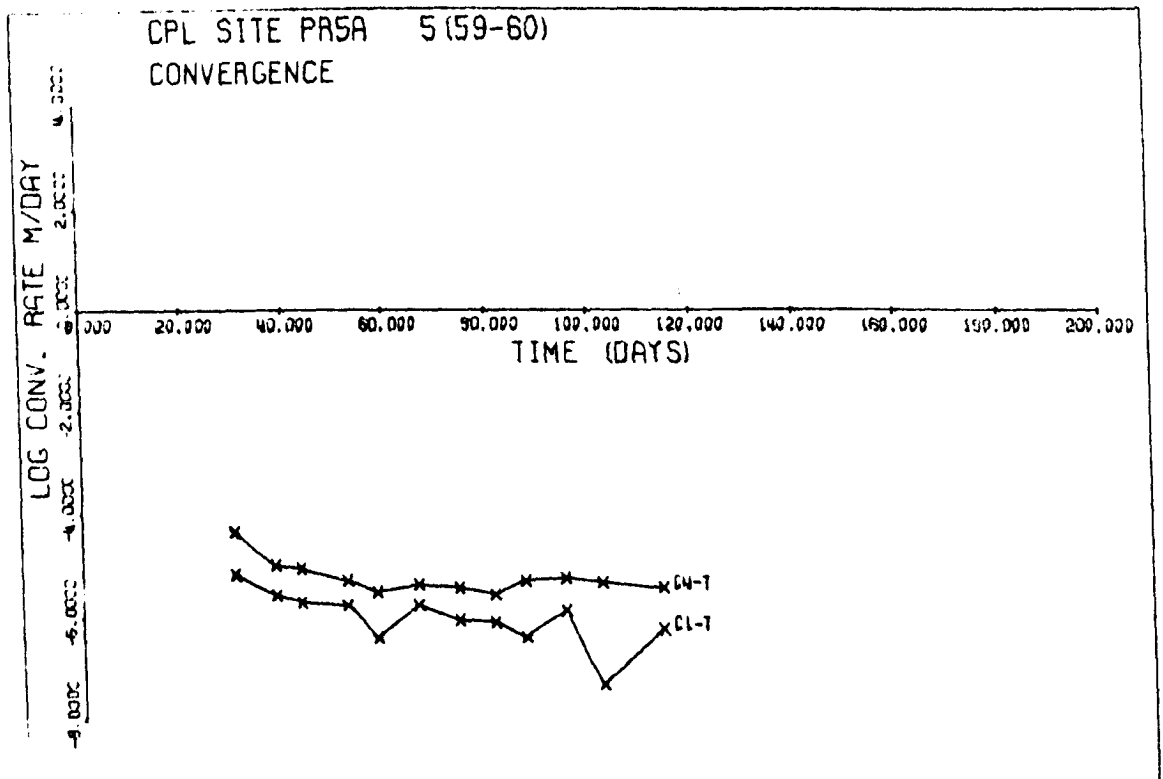
Figure 6.23 (a) No.12 Panel Closure and Closure Rates

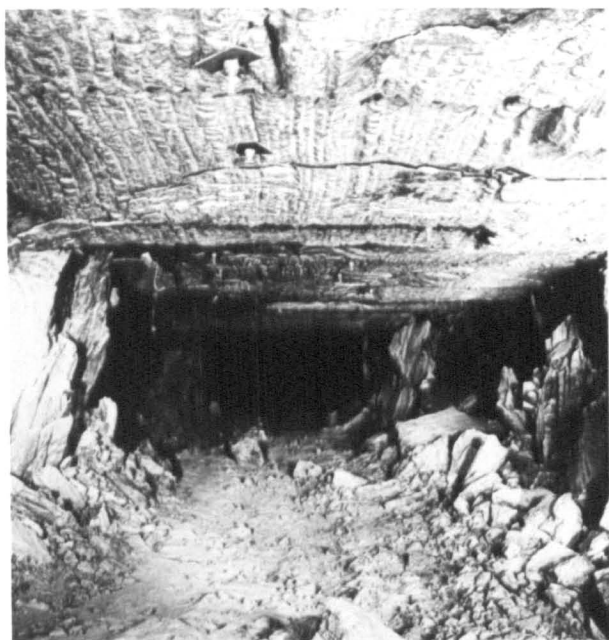
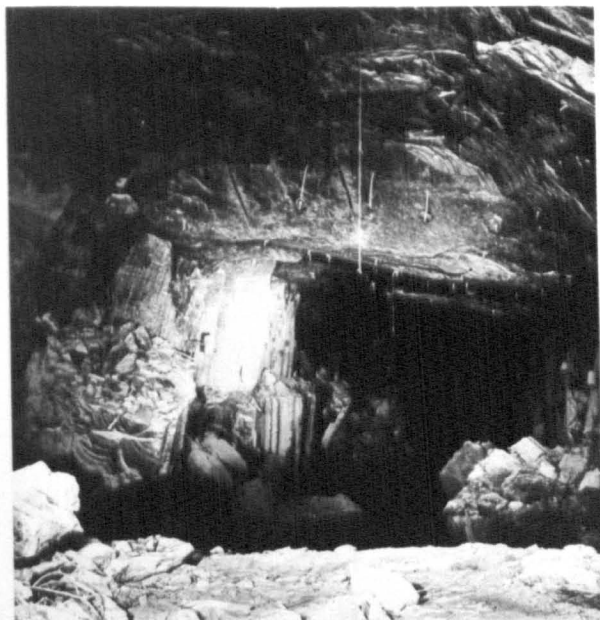
No.12 Panel 24/4/1980

- 1 06/64 Looking West
- 2 06/64 Looking West
- 3 06/64 Looking North into stub.
- 4 06/64 Looking East

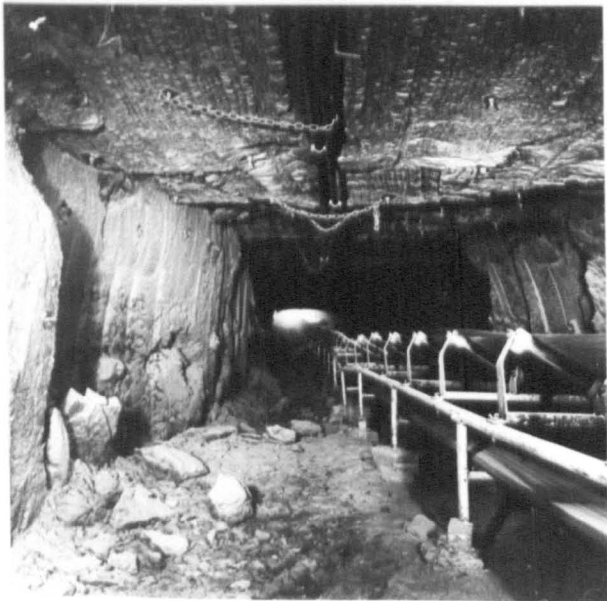
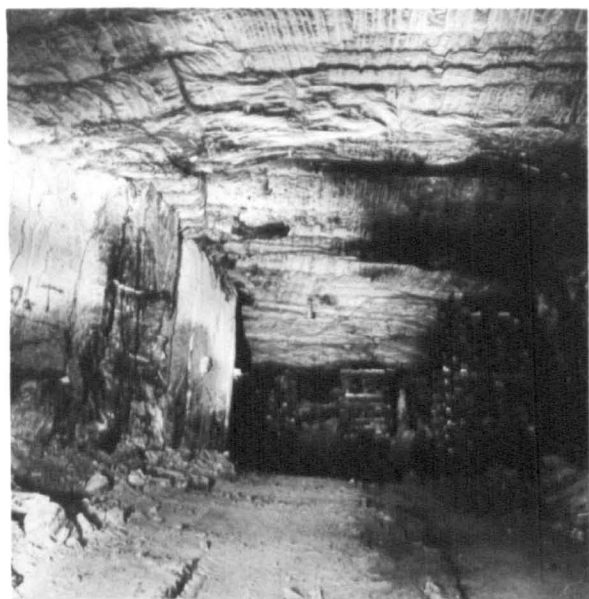
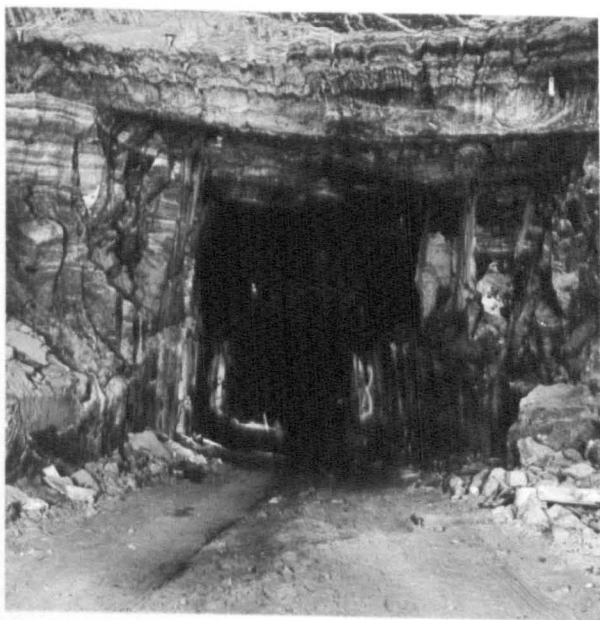
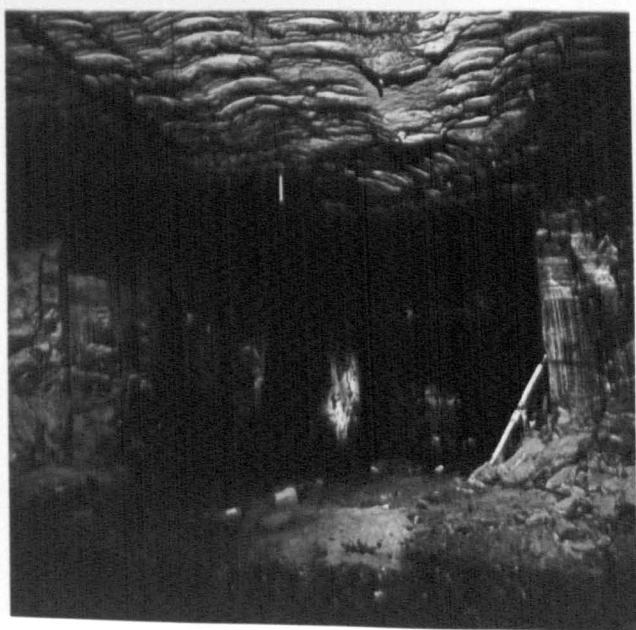
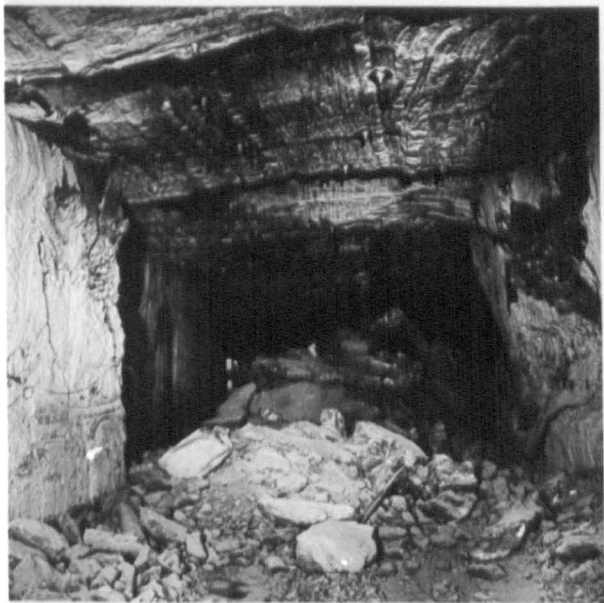
Plate 6.14

No.15 Panel 'A' sites
15/5/1980

- 1 L/08 Looking West
- 2 L/08 Looking North
- 3 L/08 Looking East
- 4 L/08 Looking South at No.8 stub

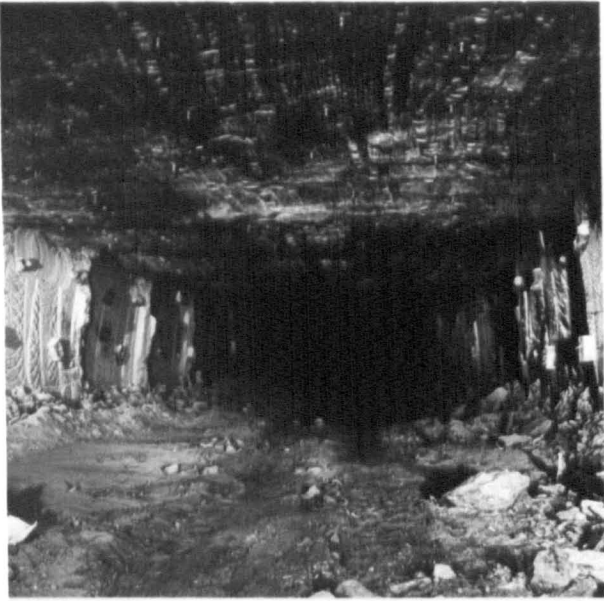
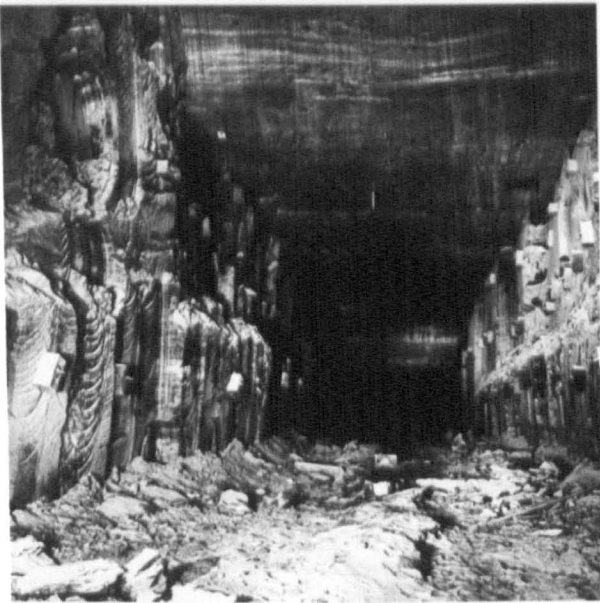
No.15 Panel B Section
15/5/1980

- 1 F road at R.M. site looking East
- 2 J/17 Cross cut looking South at R.M. Ext. site 17 15 B
- 3 E roadway at 16 Cross cut looking West
- 4 Looking East at North sidewall at 16 Cross cut

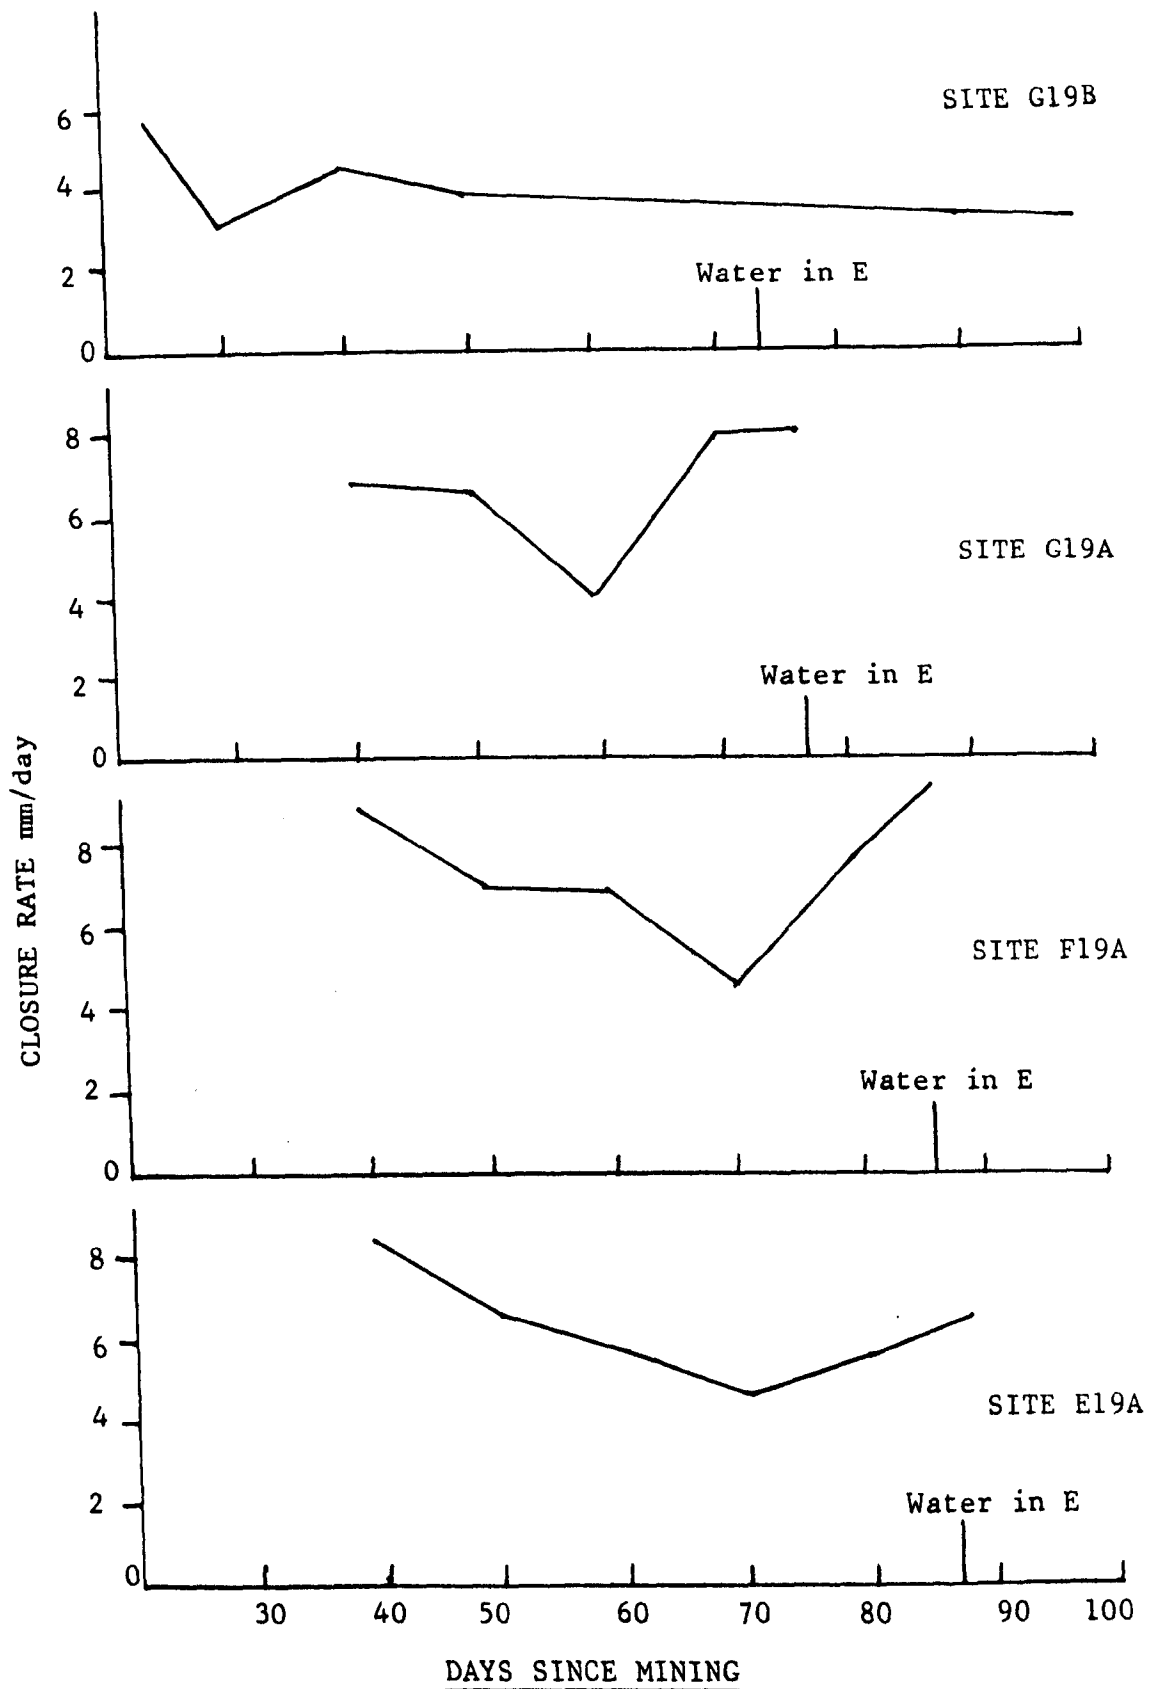
Figure 6.38 No. 19 Panel, Microcreep closure rates at E19A, F19A, G19A and G19B

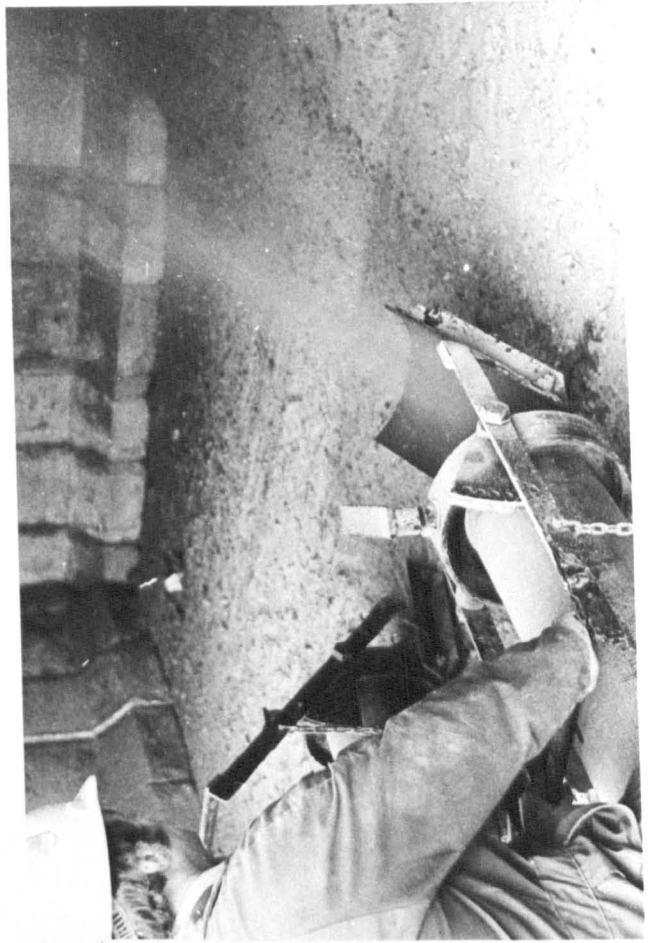
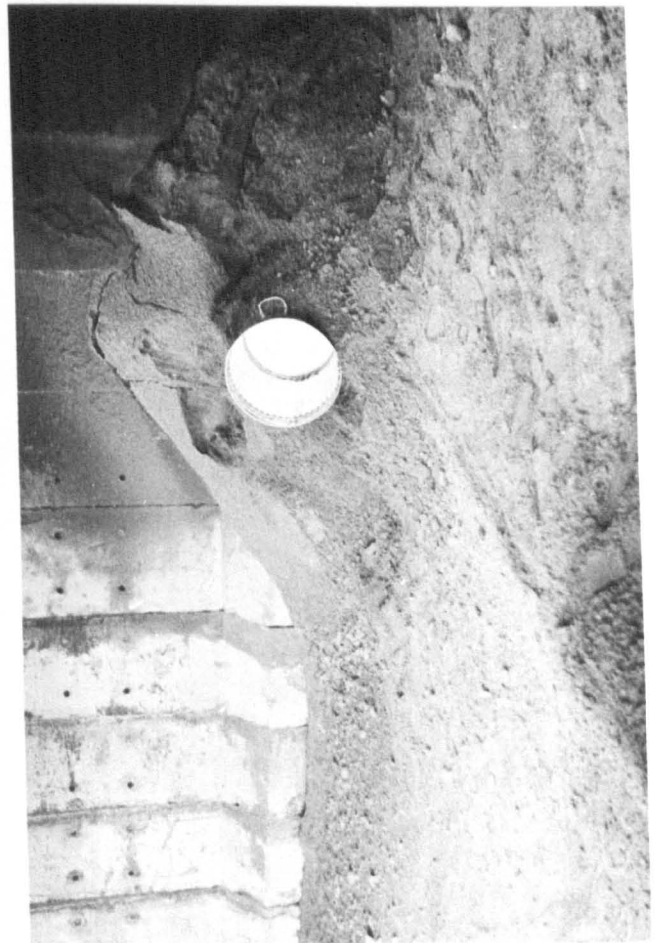
Plate 7.1

- 1 Mock up roadway on surface.
- 2 Markham Stower.
- 3 Bin for catching fill materail.
- 4 Stowing nozzle.

The Markham Stower acquired by the mine was set up on surface in the r.o.m. potash storage shed and a test tunnel erected nearby. This was constructed of precast concrete segments, Plate 7.1. As r.o.m. rocksalt was not available, it was decided to use r.o.m. potash instead. Drums were set at different positions in the tunnel and potash stowed into them in order to try to assess the stowing density. From the eleven drums of stowed potash, the average stowed density was calculated to be 1.44 gr/cm^3 , with values ranging from 1.38 to 1.58. No correlation between the drum location and density was found. The uncompacted density of r.o.m. salt was found to be 1.28 gr/cm^3 and that of r.o.m. potash, 1.37 gr/cm^3 .

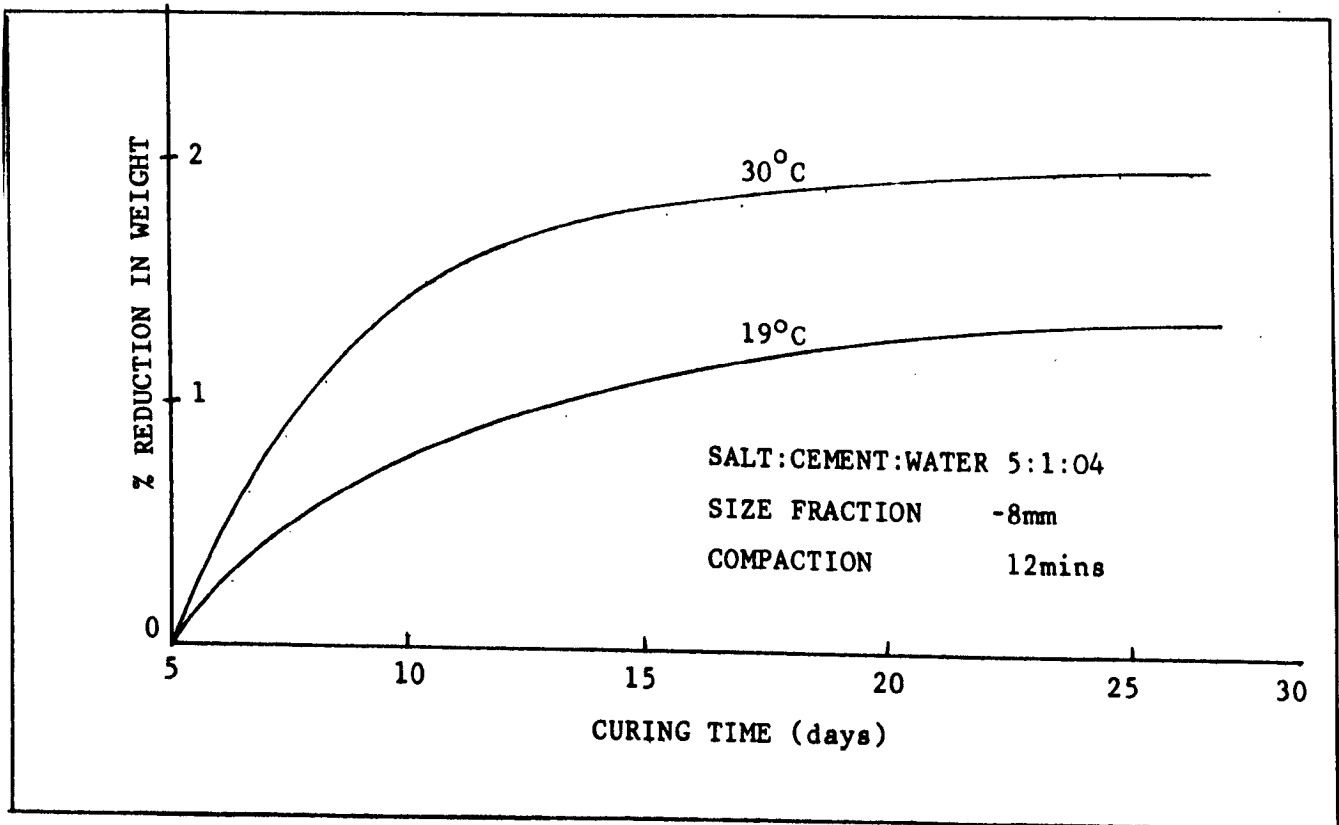
Figure 7.2 Effect of variation in curing time on saltcrete

with time as a result of different rates of hydration. Hydration is the diffusion and subsequent chemical reaction of moisture throughout the saltcrete. More rapid hydration produces accelerated setting which generally results in lower strength.
