STABILITY OF EXCAVATIONS AND DESIGN OF MINING

LAYOUTS IN A DEEP LEVEL POTASH MINE

A THESIS

H.D.S. MILLER B.Sc., (Wales)

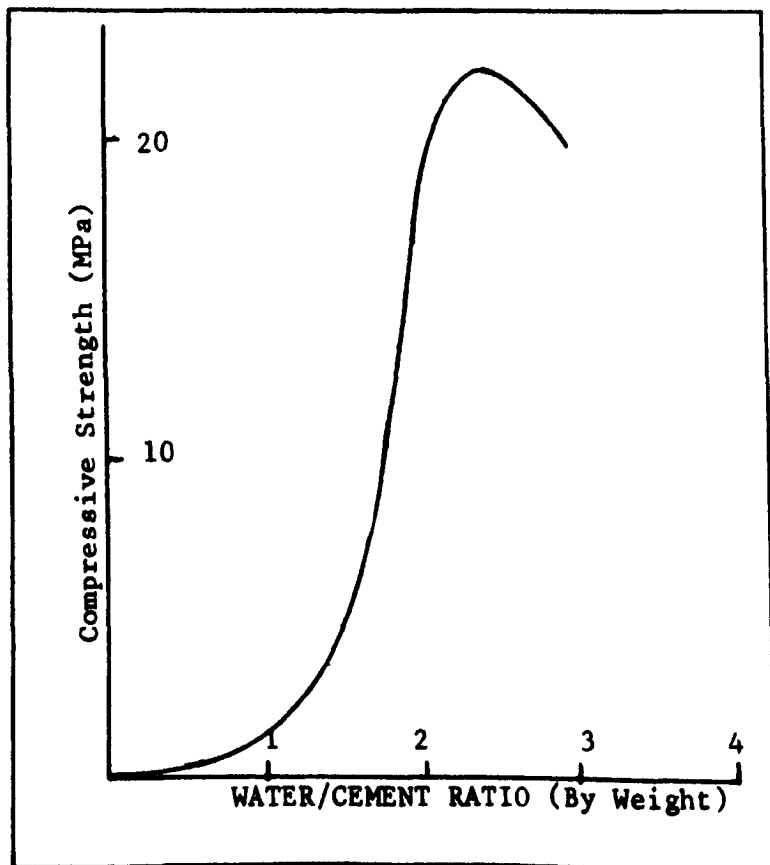
Figure 7.9 Water/cement ratio vs. strength

For normal Portland cement, one part by weight of cement requires 0.26 parts by weight of water for complete hydration⁽³⁵⁾. However, this mix would be very dry and exceedingly difficult to work. Extra water is therefore added to lubricate the mix. As all excess water evaporates when the saltcrete dries, leaving voids, it is important that this excess is kept to a minimum. Figure 7.9 gives the results of varying the water/cement ratio on the strength of saltcrete specimens. A marked increase is noted from a ratio of 0.25 to 0.5. It was noted that with the increase in water/cement ratio, water tended to separate out when being vibrated. The optimum ratio would appear to be between 0.4 and 0.5, a result which is in agreement with Forster⁽³⁴⁾.

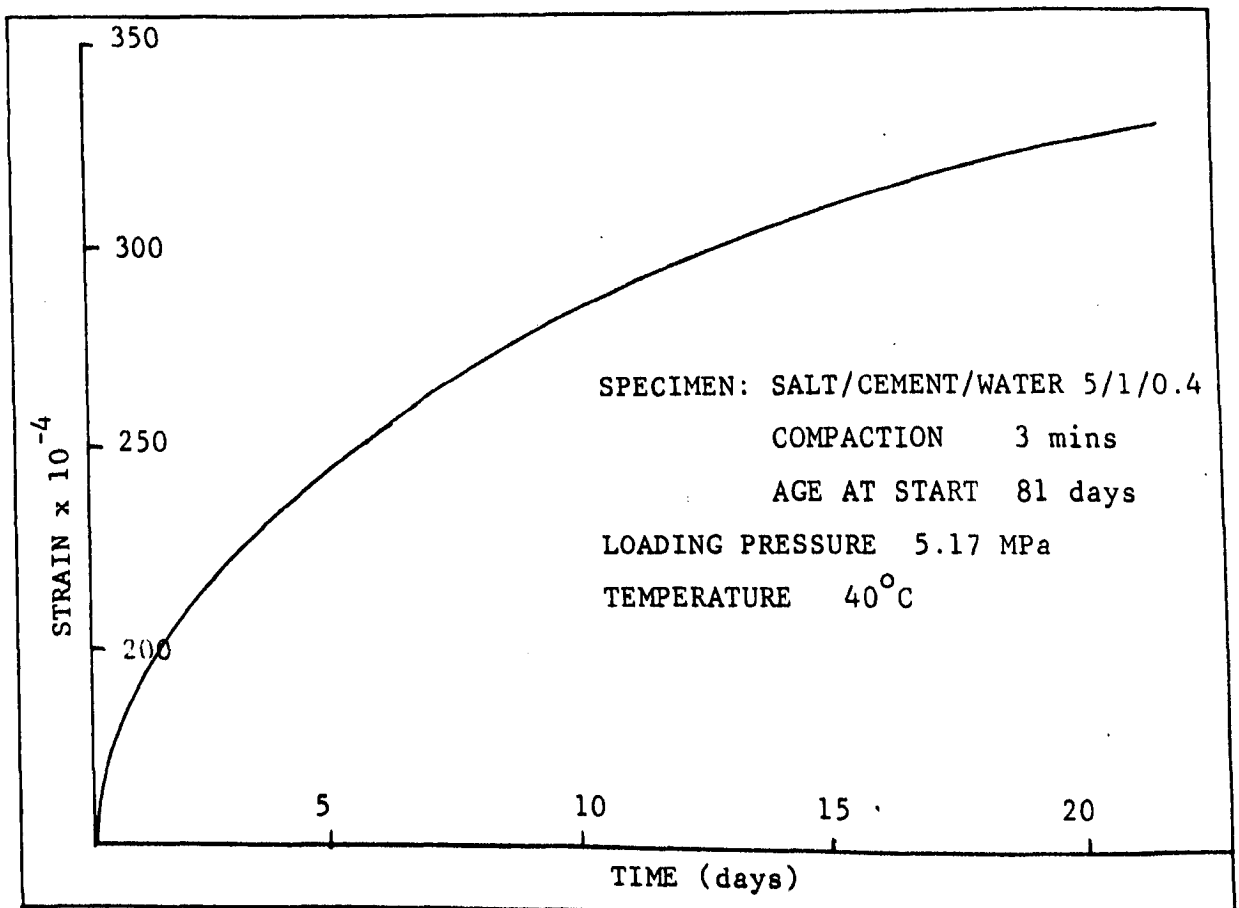
Figure 7.11 Creep Test

is shown in Plate 7.2. The specimen was loaded uniaxially to approximately 50% of its ultimate compressive strength, and was sleeved with rubber to prevent a loss of water due to evaporation. To simulate underground conditions, the test was conducted at 40°C. The results are given in Figure 7.11. It would appear that under the test conditions prevailing, the saltcrete was still in a state of primary creep after 28 days, following a curve of the general form $\dot{\epsilon} = A \log B$. The test was terminated after 28 days and a modulus of 4.85 GPa was obtained when the specimen was unloaded.

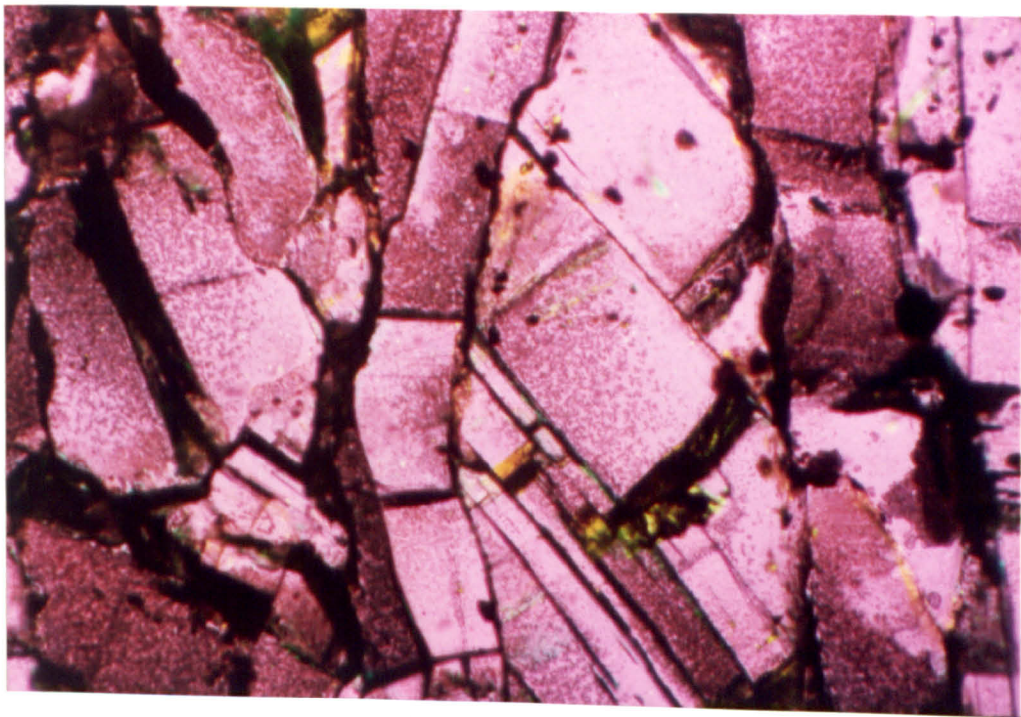
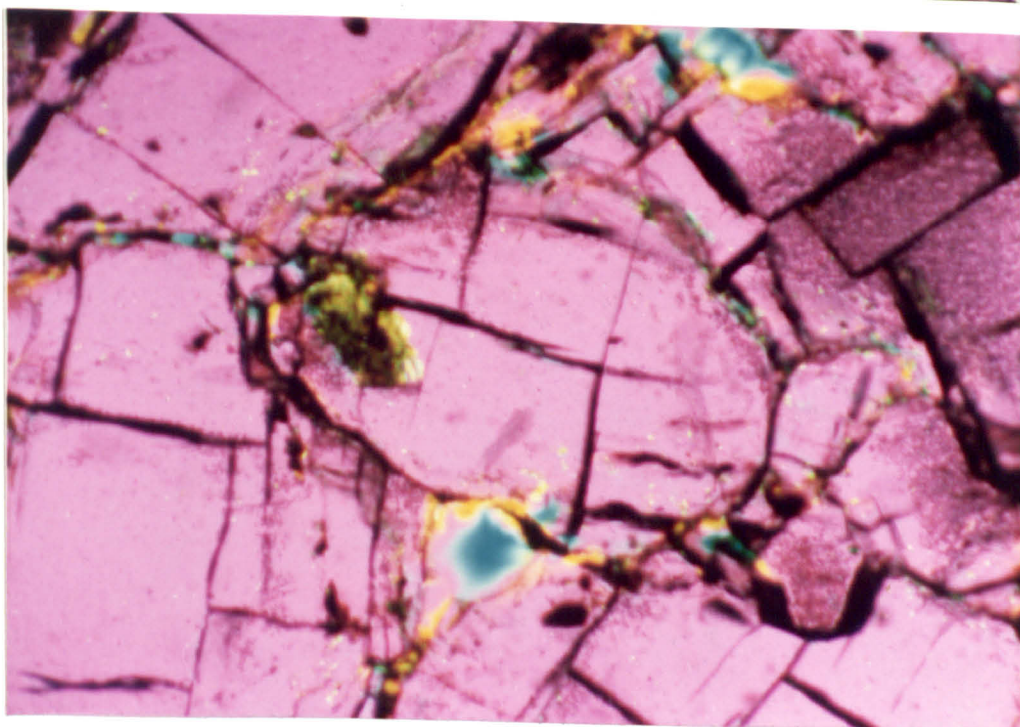
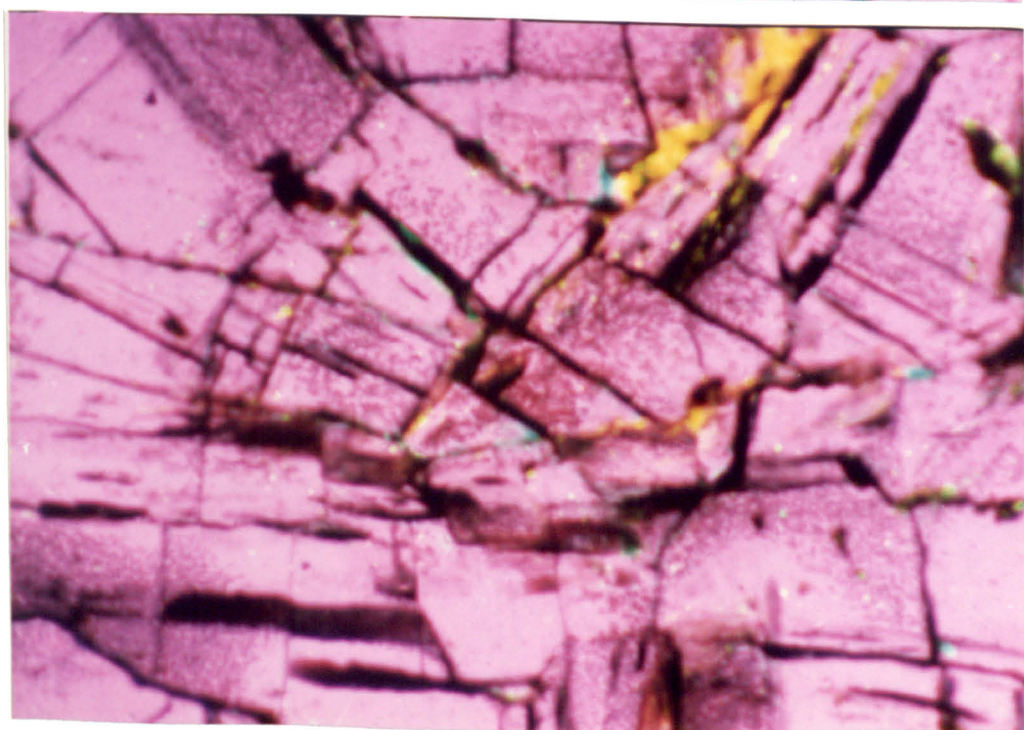
PLATE 8.3

- A. Section along C_{13} . Note bent grain in the centre of viewfield. Also shearing in vertical plane of photo and at 45° .
- B. Section along C_{23} showing fracturing of rounded centre grain and also dilation of cleavage.
- C. Section along C_{12} showing highly fractured and sheared groundmass.

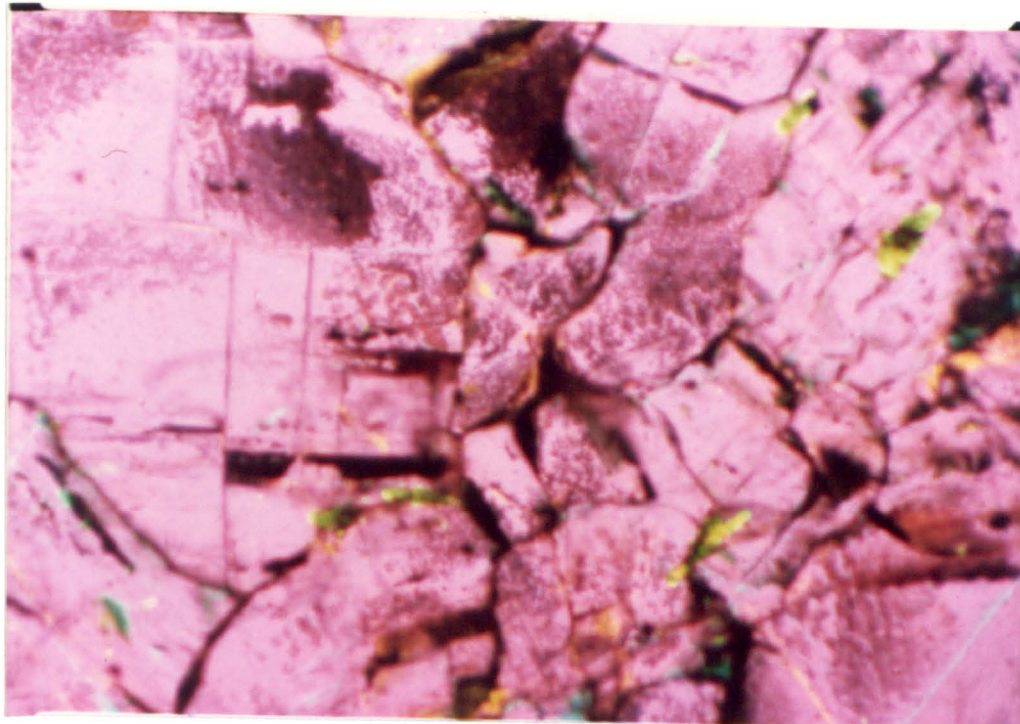
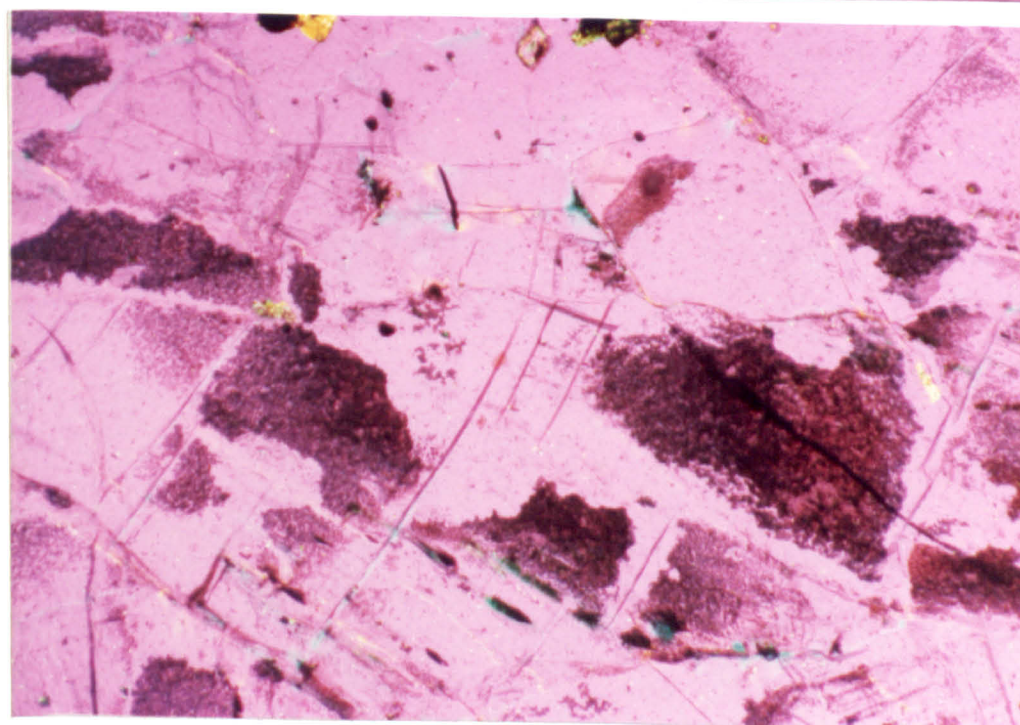
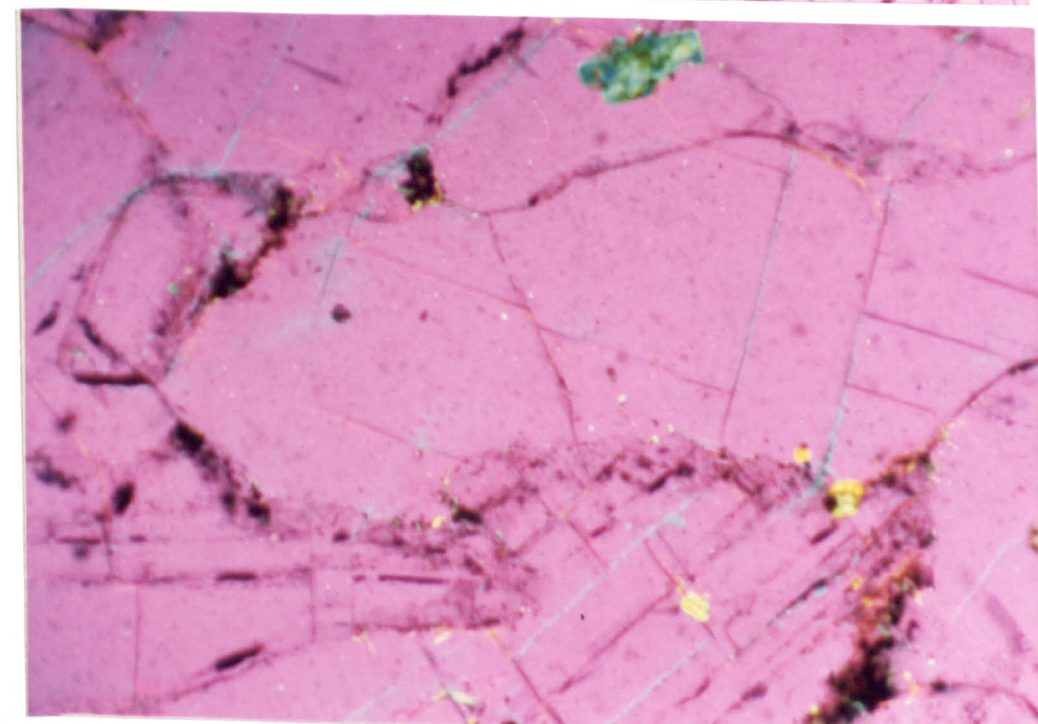
PLATE 8.4

- A. Section along B_{13} showing limited shear and some budding of cleavage fractures.
- B. Section along B_{12} showing fracturing and rotation of grains. Note how fracturing is more intense in this plane than the other two.
- C. Section along B_{23} showing interference colours along cleavage fractures.

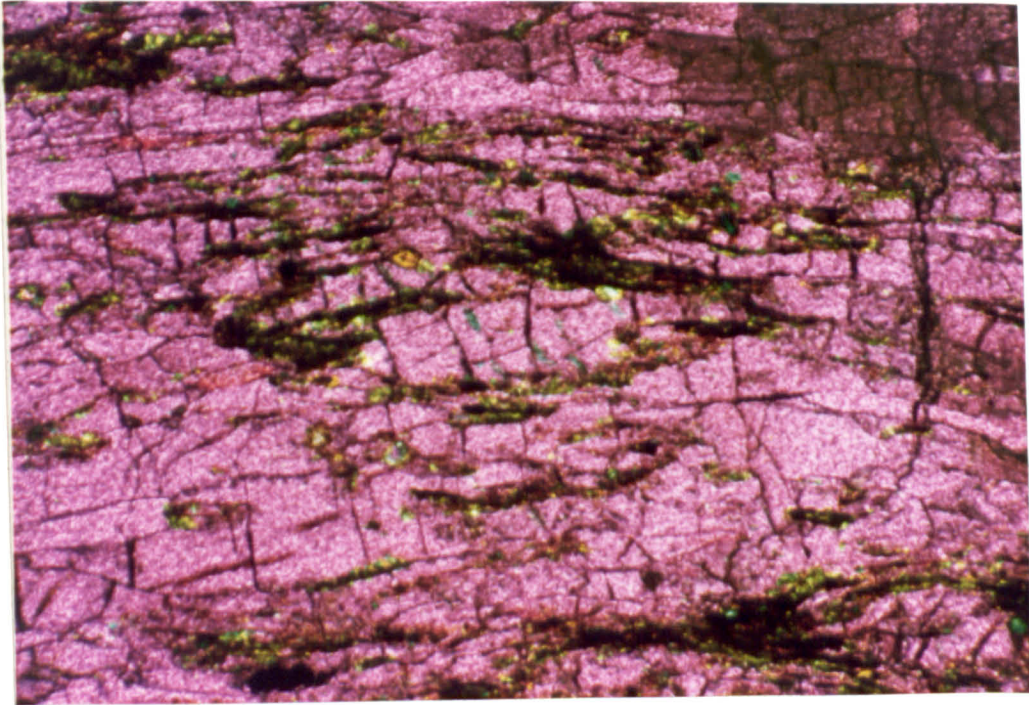
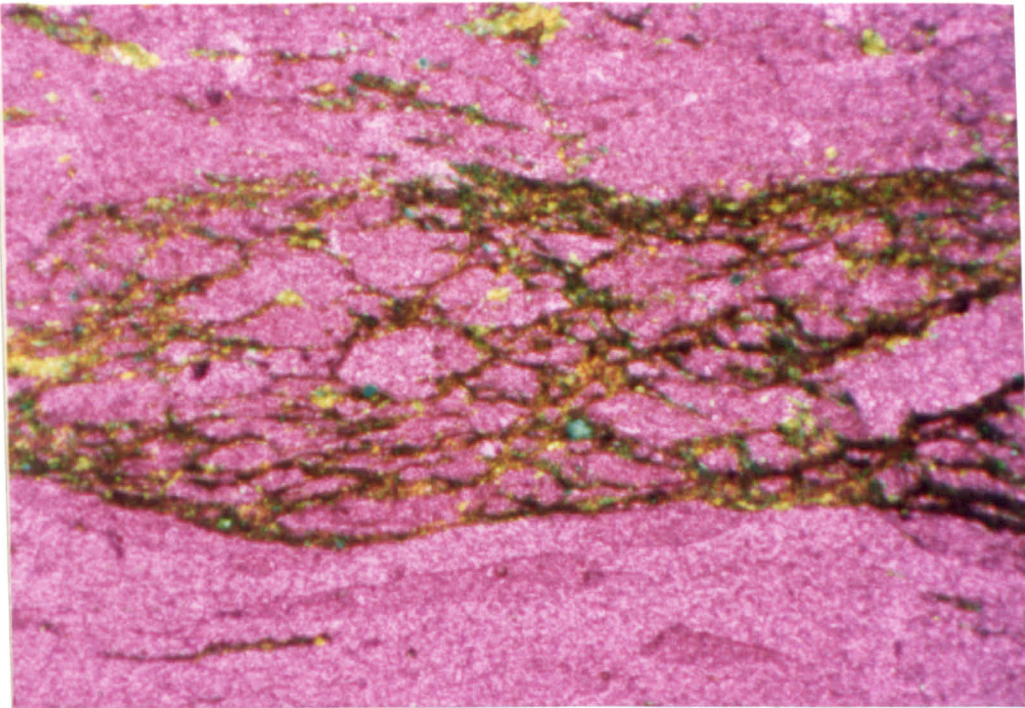
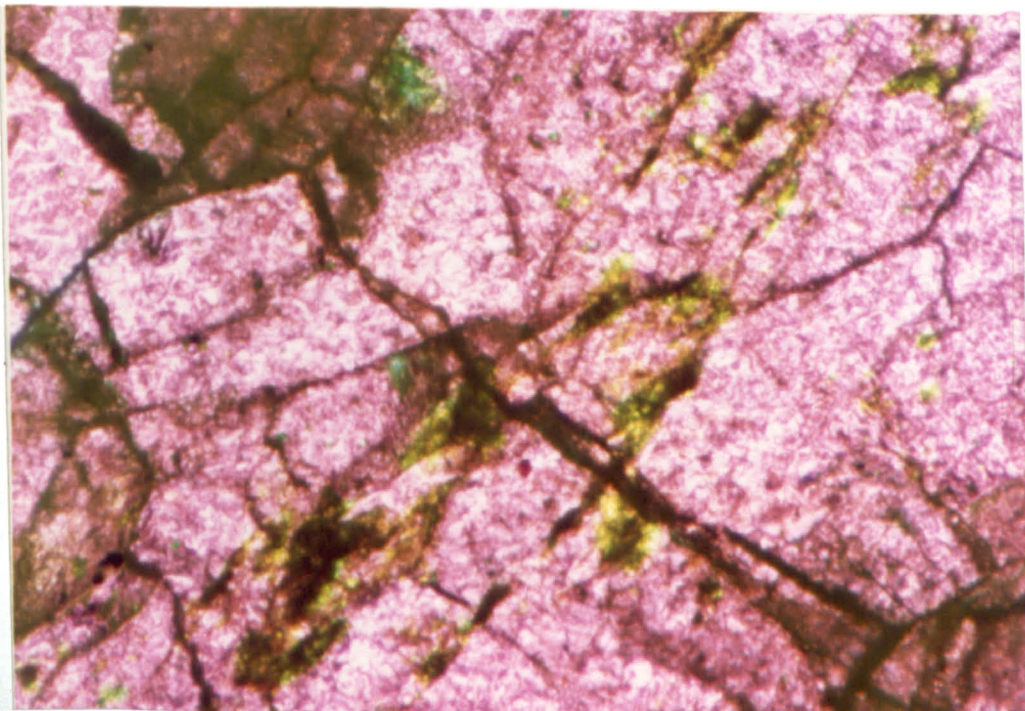
- A. General view showing highly fractured ground mass
flattening of clay inclusions and a "pseudo-metamorphic"
appearance.
- B. Showing development of boudinage type structure.
Necking due to load being applied across layers of
dissimilar viscosities.
- C. Grain showing shearing off and rotation at corners
(mag x 75).

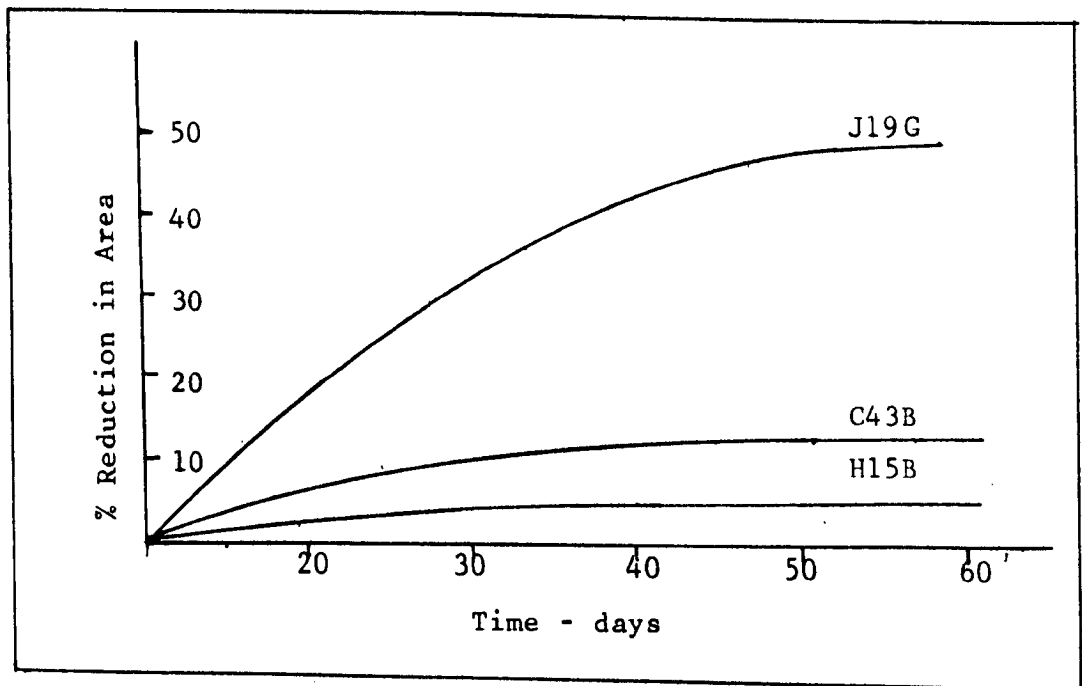
Figure 10.1 Change in roadway area with time

and J 19 G for different values of t and the results are depicted in Figure 10.1, with A expressed as a percentage of the original area. Table 10.1 lists the time it takes to achieve various amounts of change in area for the three sites, and the difference in stability between the sites is self-evident.

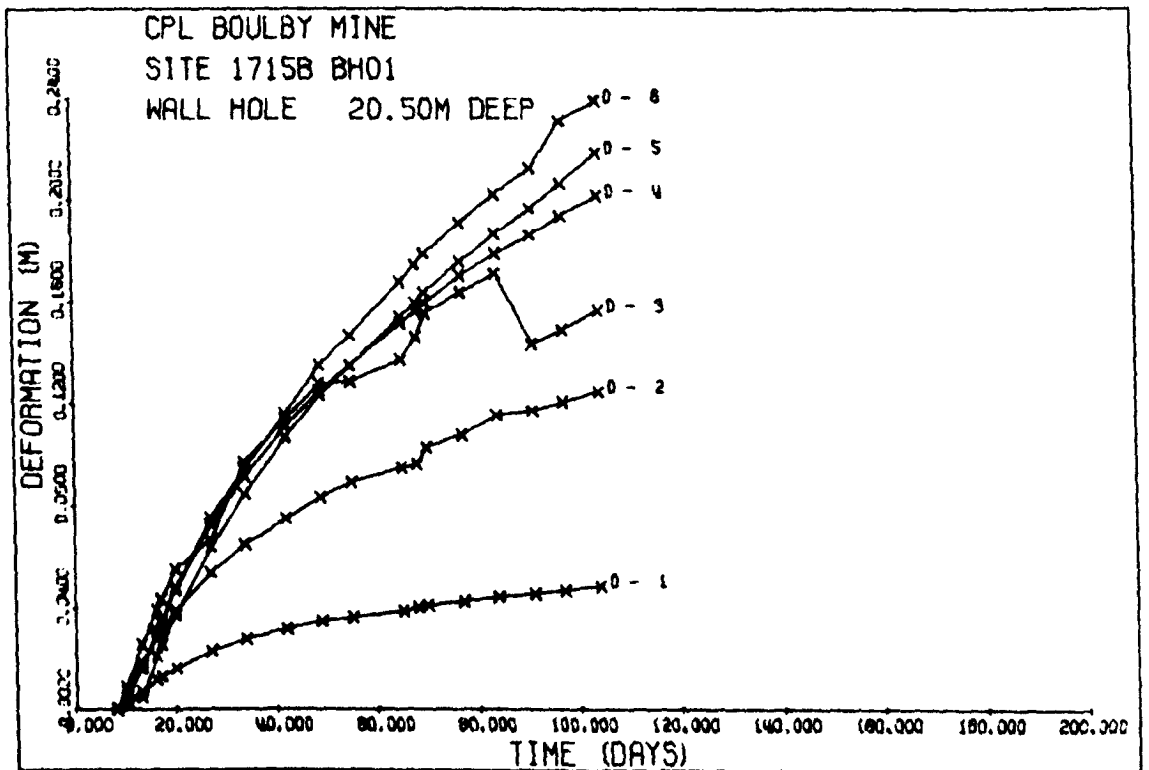
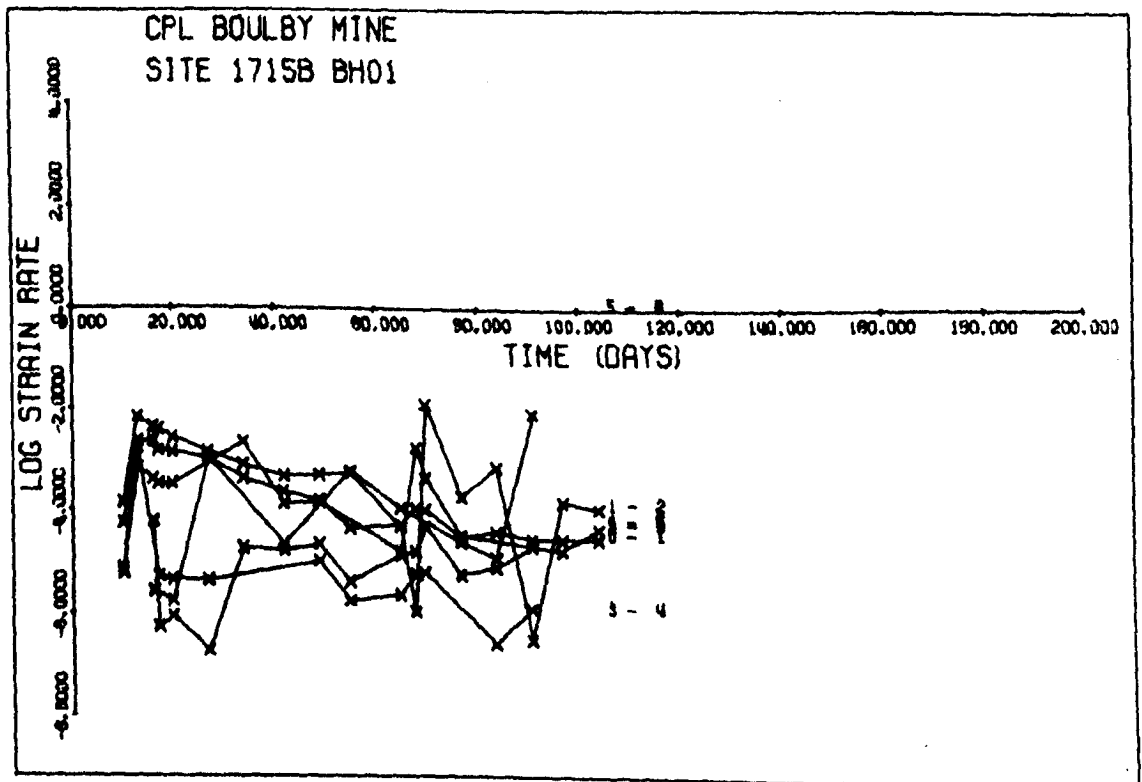
Figure 10.8 Site 17 15 B Extensometer results

The curves that show strain and strain rate with borehole depth indicate that most of the deformation is taking place in the first 6m of the pillar, a similar situation to that observed in other pillars

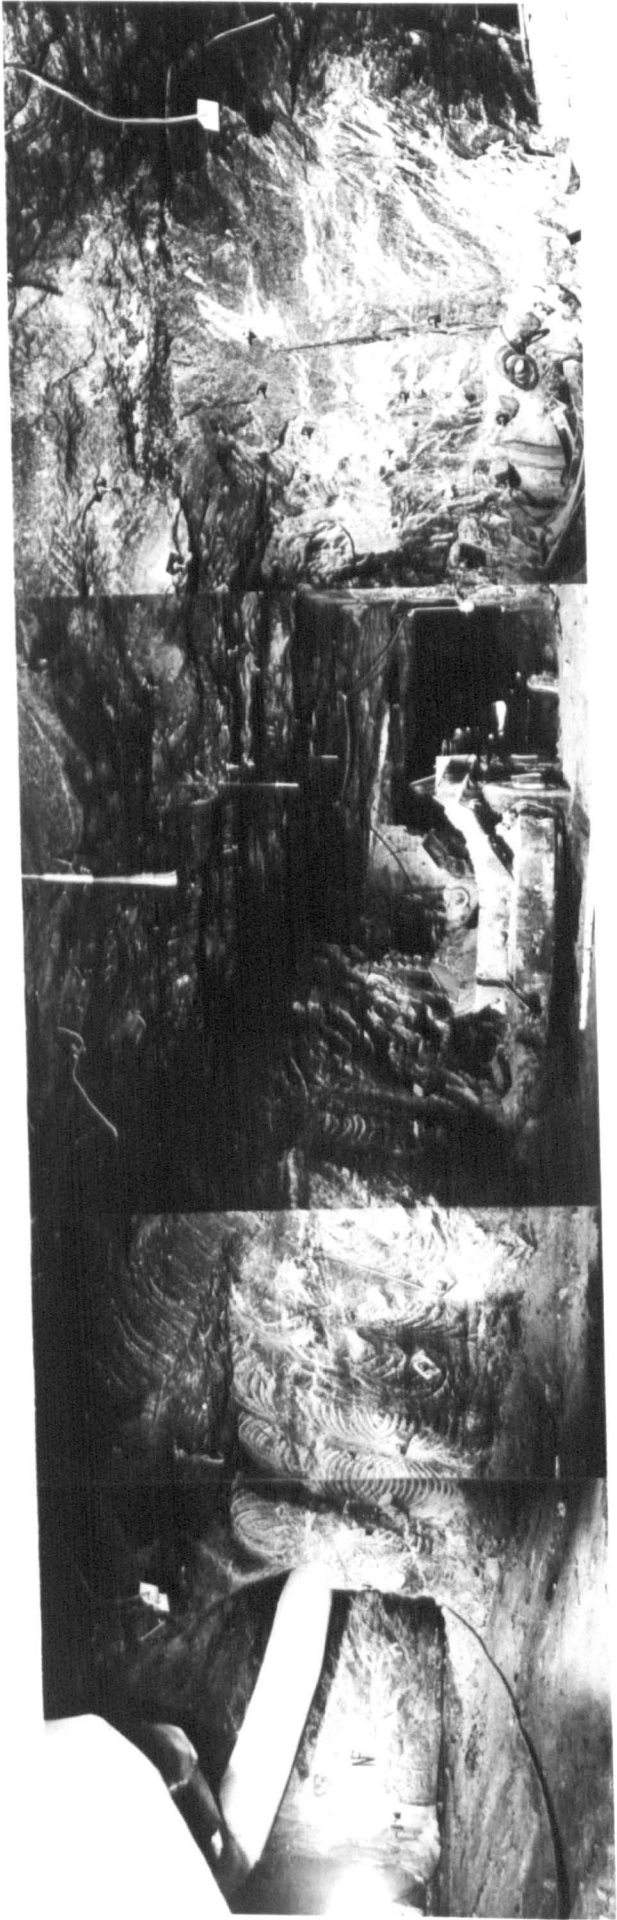
No.7 Panel - Panoramic view of new high extraction section
created by mining through old pillars.

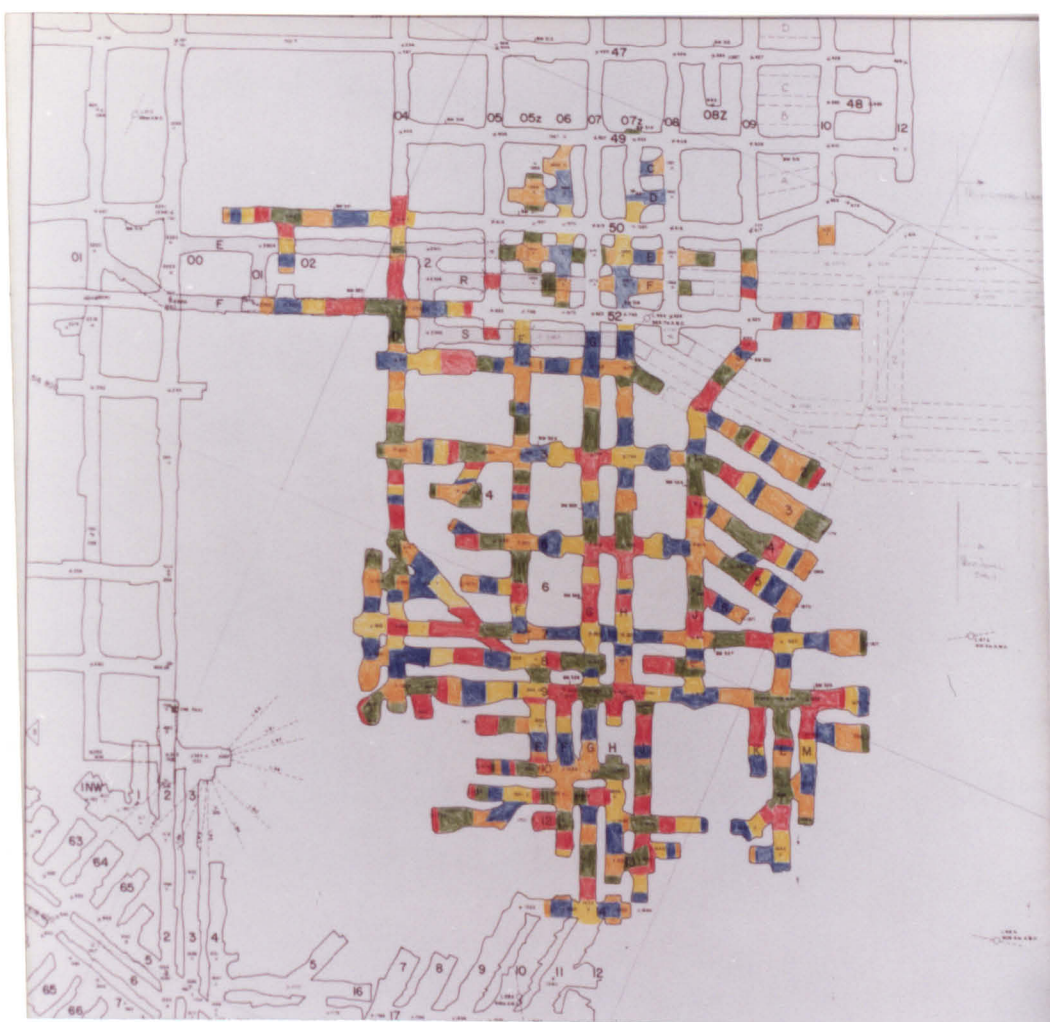
Fig.1 No.7 Panel

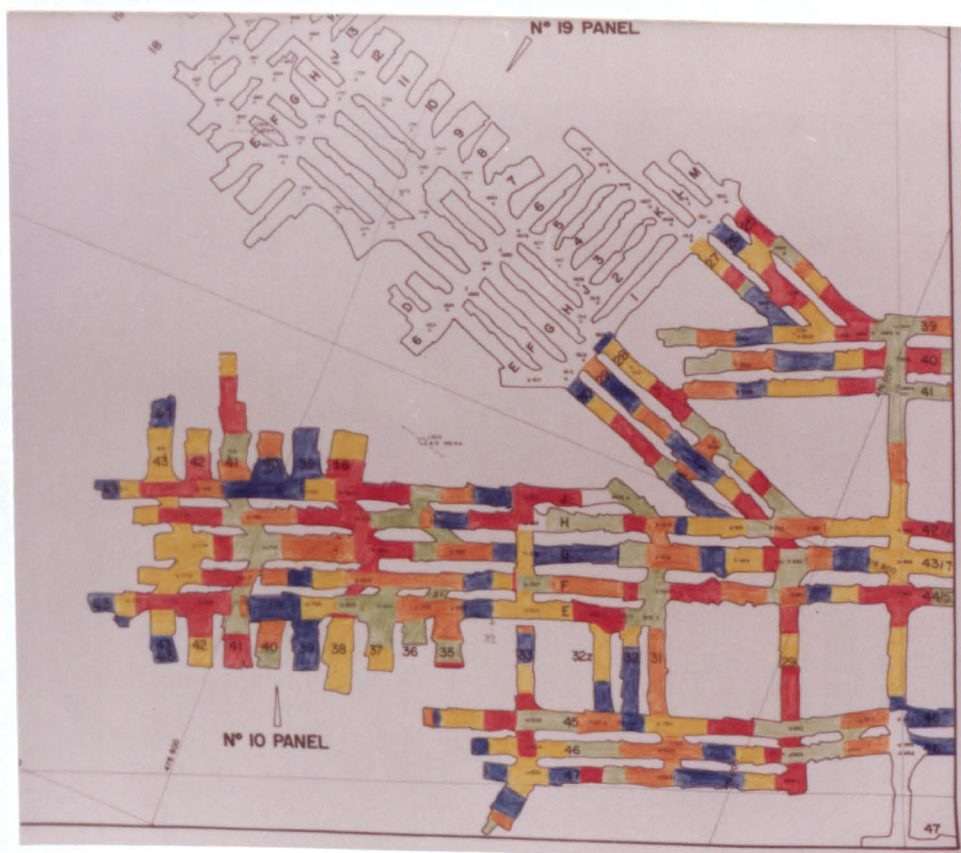
Fig.2 No.10 Panel

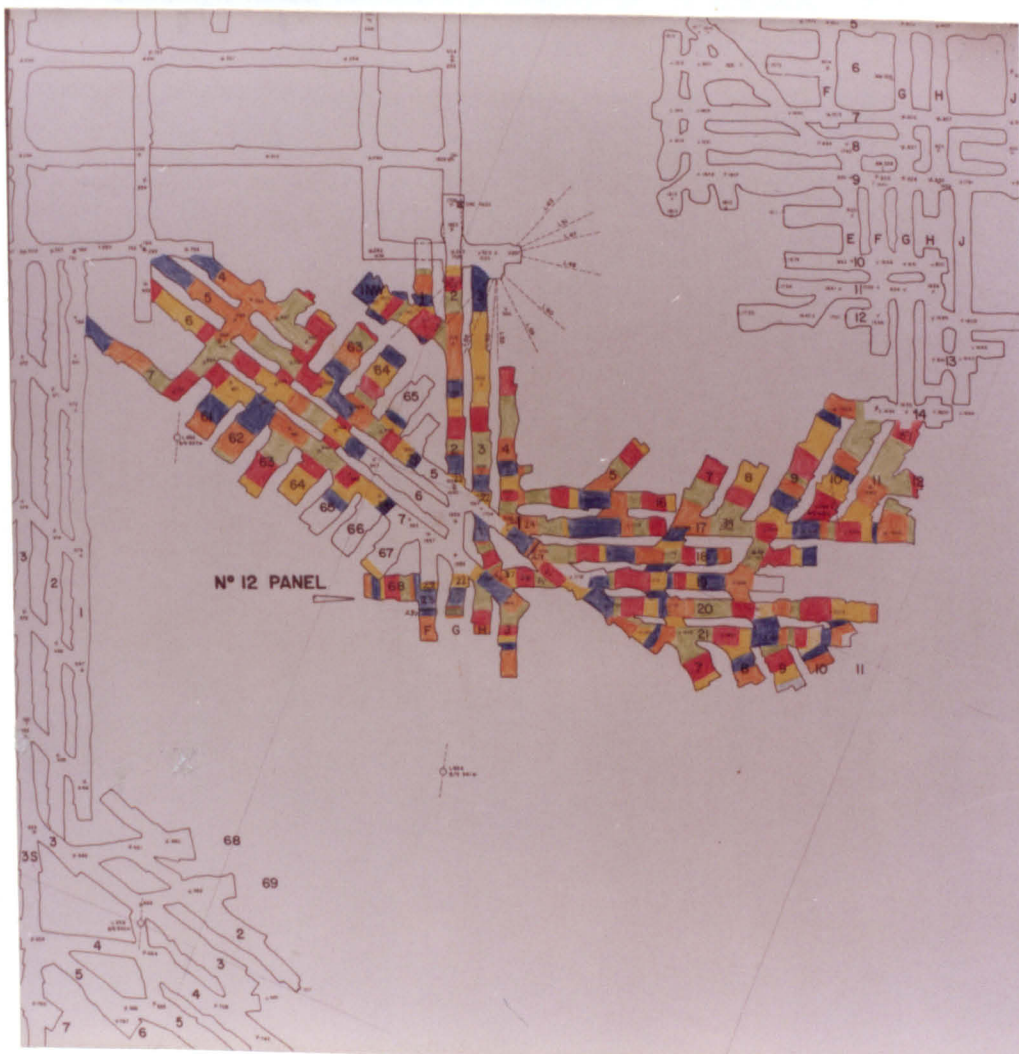
Fig.4 No.12 Panel

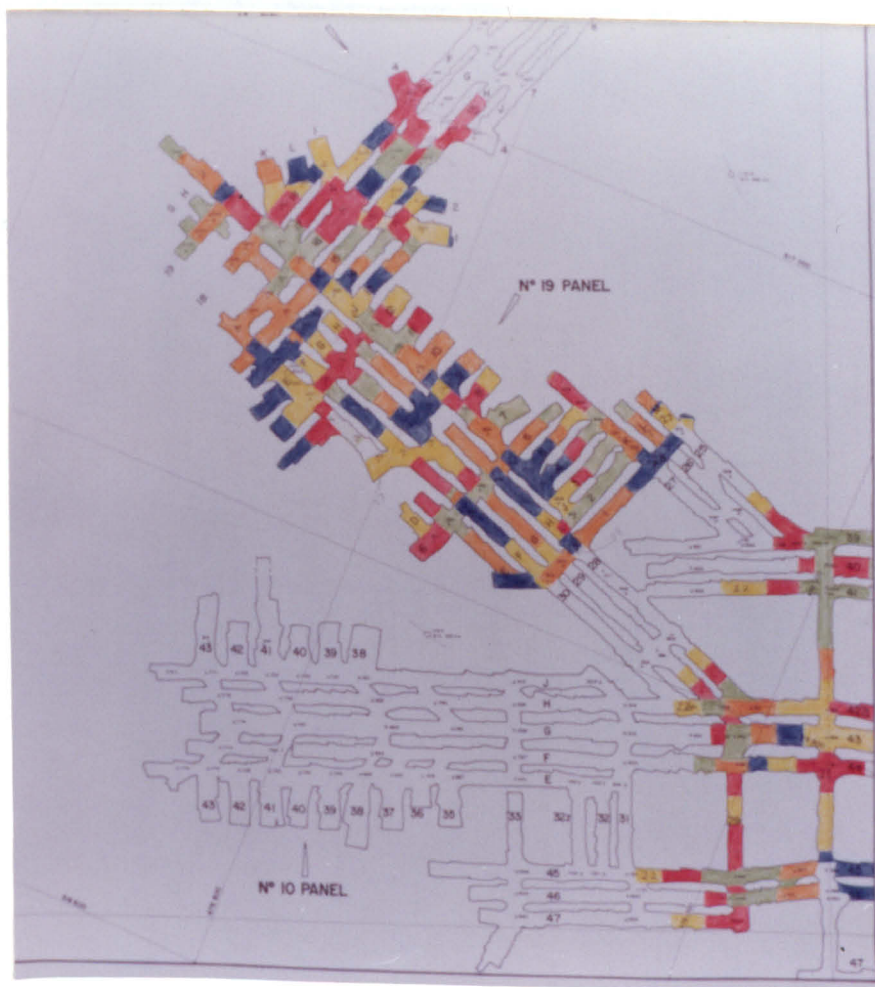
Fig.8 No.19 Panel
