FIELD INVESTIGATIONS AND HYDROLOGICAL STUDIES OF TWO

UNSTABLE, UNSATURATED SOIL SLOPES IN SAINT LUCIA, WEST INDIES

A Thesis Submitted to Newcastle University

March 2014

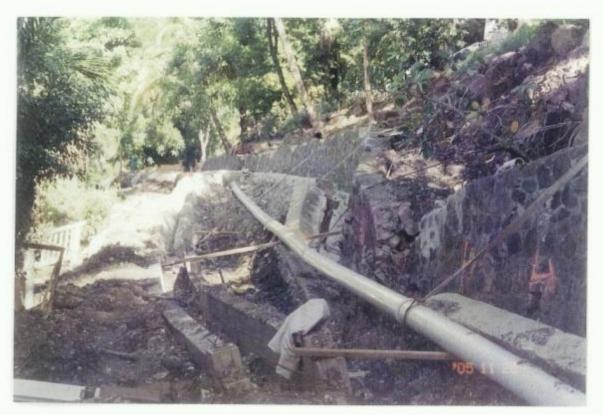
Figure 2.10 Damaged Villas 17/18 at Windjammer Landing

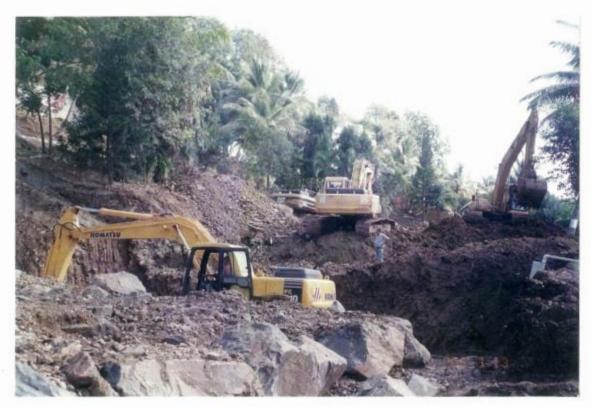
Figure 2.14 Remedial works - Excavation of failed colluvium at Windjammer Landing Resort

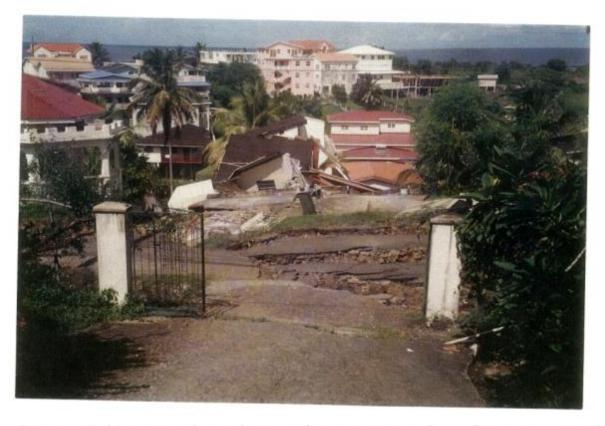
Figure 2.20 Ground displacement in access road at Tapion slide

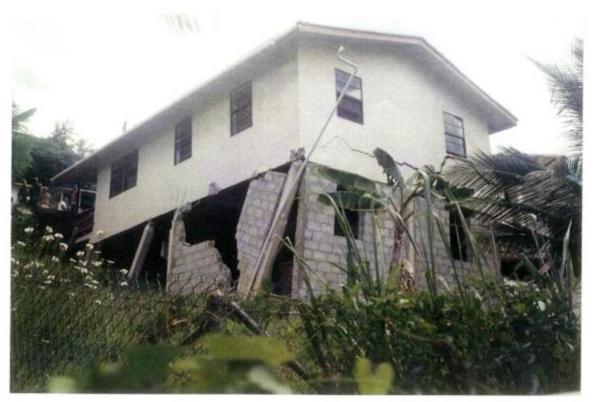
Figure 2.21 Damaged roadway and structures downslope Tapion slide

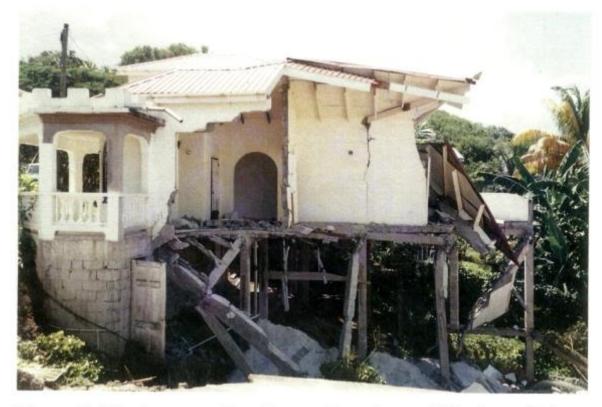
Figure 2.22 Foundation failure at crest of Tapion slide
